### 3.2.3 W. T. Peterson Community Oval – Former Fitzroy Cricket Ground

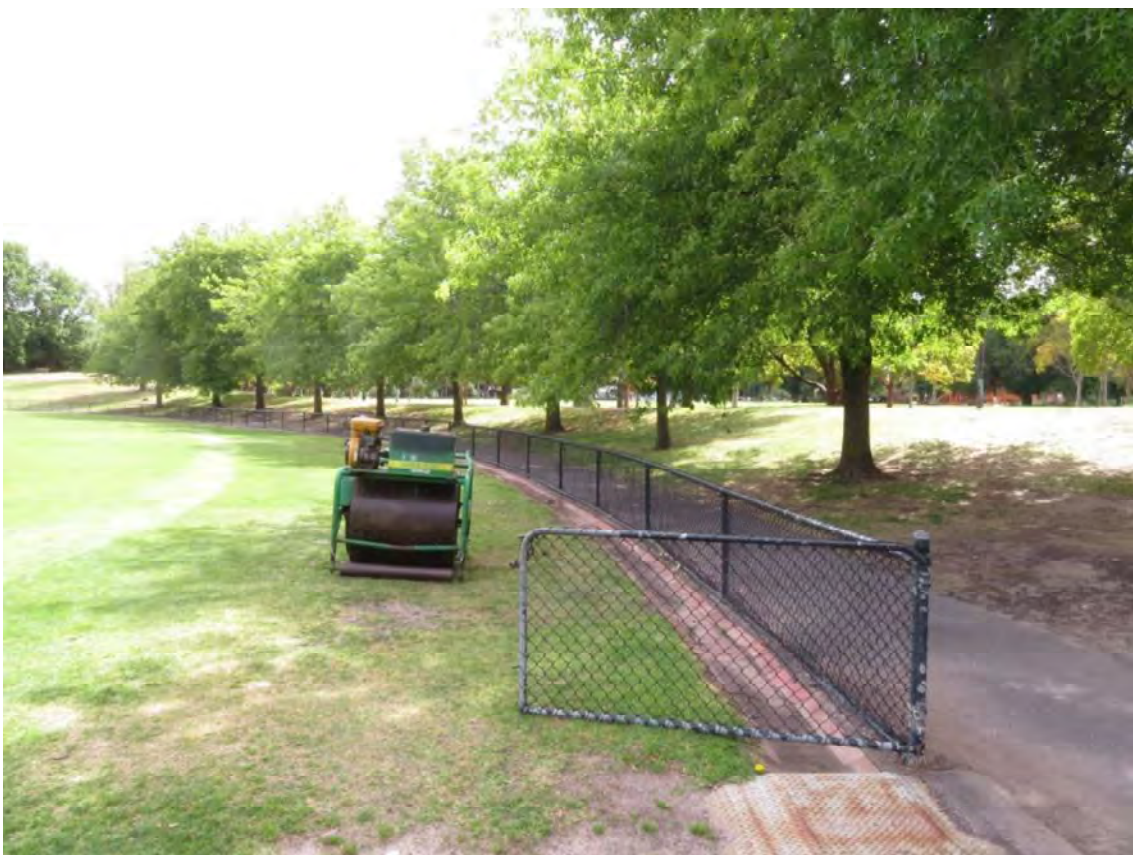
Figure 46 Brick drain, cyclone wire fence and asphalt path to perimeter of oval, with low modern treed berm surrounding.

Inside the embankments, a brick spoon drain, black cyclone wire fence, and external asphalt path presently encircle the oval. A ringing path (c. 1870s), fence (pre-1901) and brick perimeter drain (c. 1912) all constitute early elements of the oval's perimeter, although the present fabric all dates to the 1980s redevelopment of the oval. A continuous timber bench once ran around the perimeter in the later part of its use as a professional oval.<sup>210</sup>

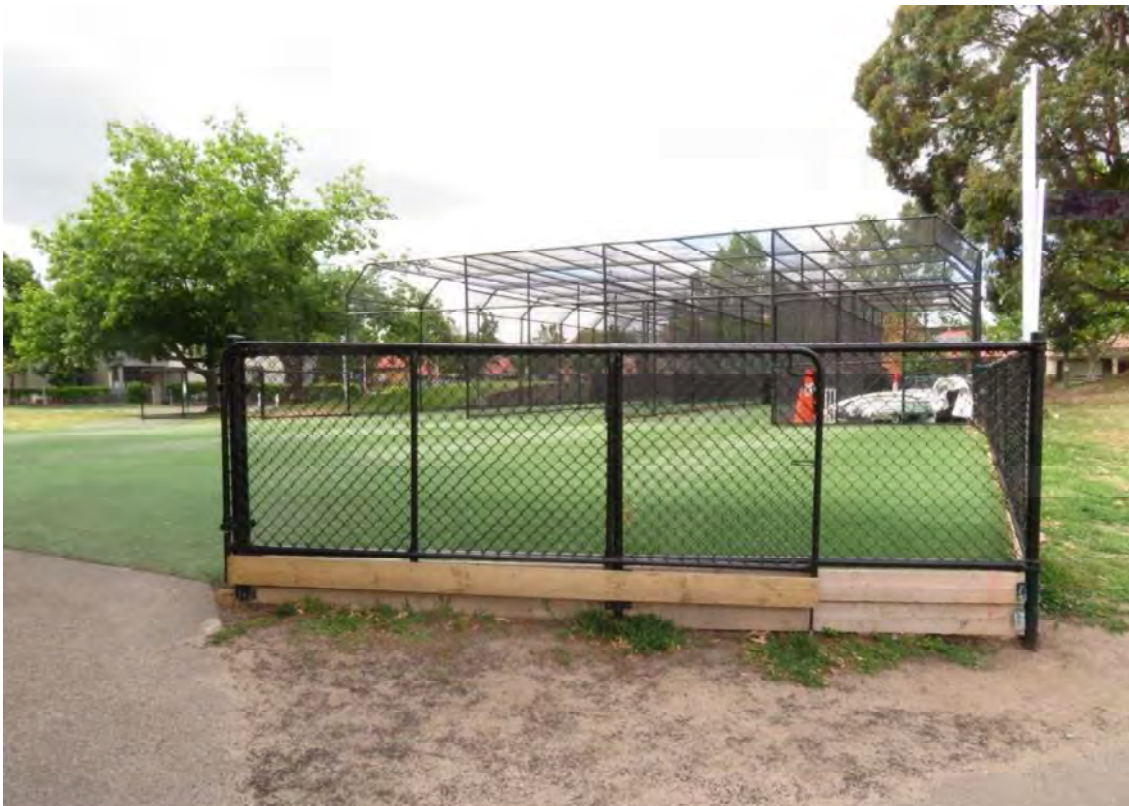
Figure 48 Cricket practice nets

At the south-east corner of the oval there are four concrete and artificial turf practice wickets in a fenced cyclone wire enclosure over a timber retaining wall. An initial set of practice wickets appear to have been installed in this location with a concrete backstop following the 1980s redevelopment of the oval; the enclosure was subsequently expanded, netted and surfaced with artificial turf.

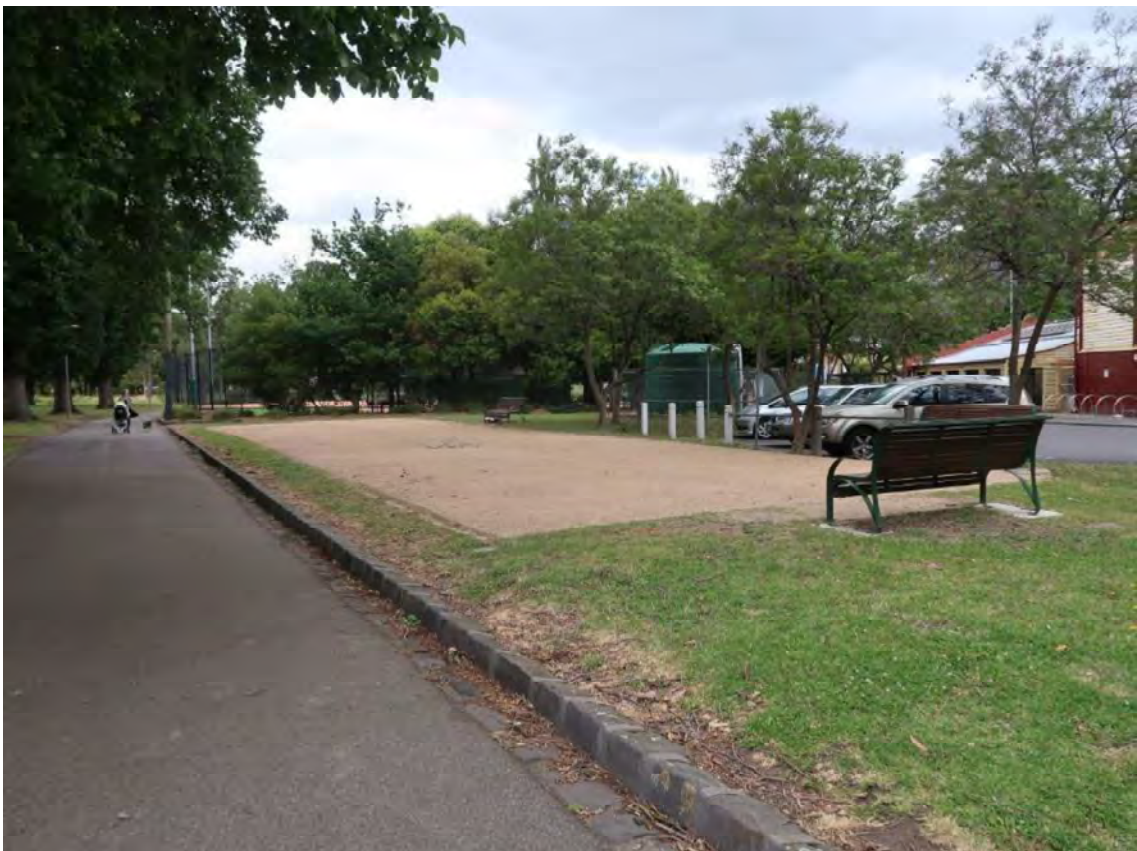
Figure 50 Bocce Court, looking east

Behind the grandstand, the car park/hardstand area was originally hedged, and was planted with a bordering row of Jacaranda (*Jacaranda mimosifolia*). The hedging was removed c. 2010, but the Jacaranda trees remain. A pair of Bocce Courts were constructed on the northern edge of this area, below the diagonal gardens path, c. 1990. Originally fenced, these were subsequently replaced with a single, unfenced court (Figure 50).

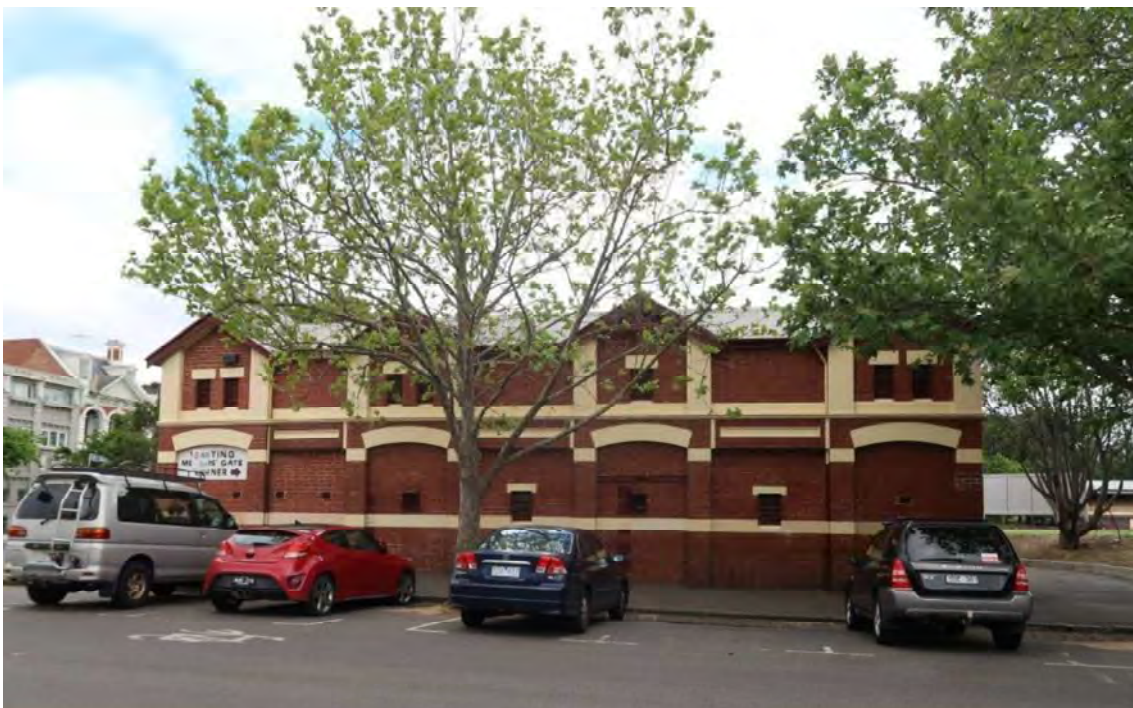
Figure 55 South façade of the Freeman Street entrance gatehouse at the original southern entrance to the oval/sport precinct

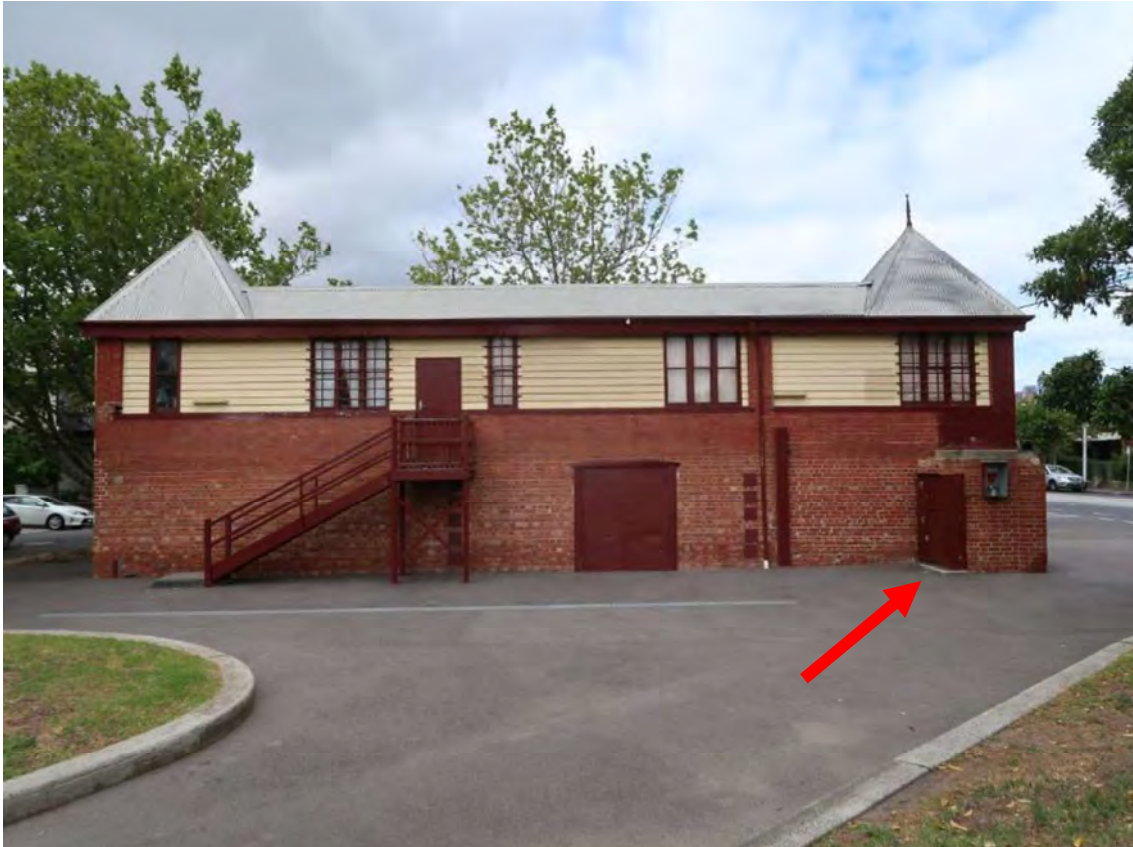
Figure 56 The north elevation of the entrance gatehouse showing the weatherboard section at the upper level and the later addition (indicated)

Abutting the centre of the north elevation is a recent timber stair providing access to the first floor. The ground level is constructed of face brickwork; with the lower section laid in English Bond (alternate header and stretcher courses) and the upper level in Garden Wall Bond. The brickwork and mortar to the lower section is lighter in colour, possibly due to it being covered by soil for a long period of time. The west end is partially overpainted. A double-leaf flush panel door is located to the centre of the ground floor. Tie-rod plates, coinciding with the interior stabilising structure, and various fixtures are located on this façade. The first floor has a weatherboard infill, between the two end brick walls and a brick column at the western end. The weatherboards are punctuated by a non-original flush panel door and non-original tripartite timber-framed, double-hung sash windows fitted with metal security bars. A small red brick addition with a flat concrete roof is located at ground level at the western end of the north elevation. An electrical cupboard is fixed to its east side.

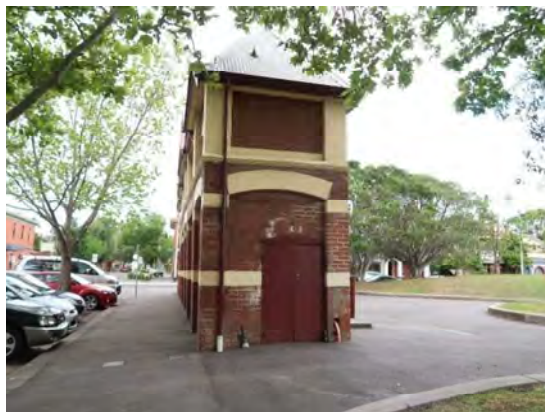
Figure 57 East elevation of the entrance gatehouse

The east elevation is formed by a recessed brick panel at the ground floor with a rendered segmented-arched head and non-original double-leaf flush panel door. At the first floor is a blank recessed brick panel. The west elevation is similarly detailed, although there is an infilled window/door opening at the first floor; a door is not evident in this location in Figure 54. The ground level arrangement, including the rendered arch over the early entry, has been modified and the lower section of the façade has been overpainted.

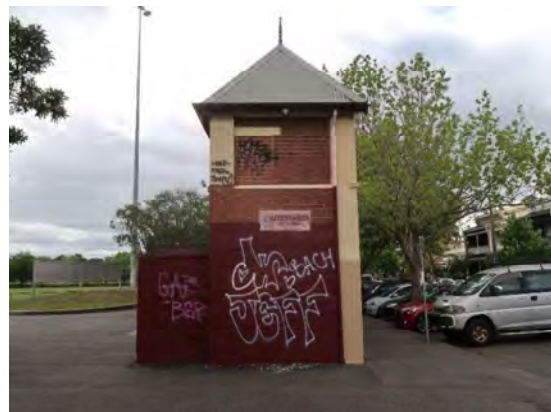
Figure 58 West elevation of the entrance gatehouse; note the former ground level entry has been infilled

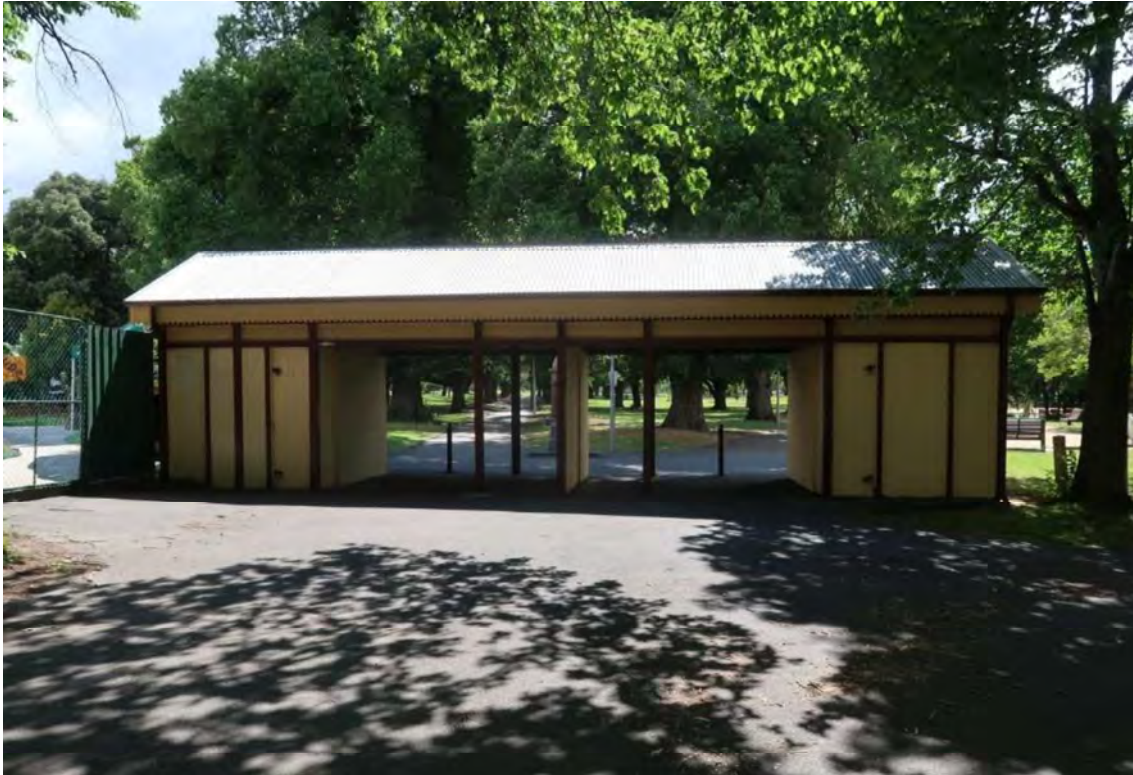
Figure 61 The reconstructed timber entrance pavilion in its current location, viewed from north-east

The entrance pavilion (Figure 61) is a utilitarian, timber-framed building on a narrow, rectangular plan. It has a framework of stop-chamfered timber posts and beams with V-jointed board cladding. Passing through the centre of the pavilion, are two wide openings fitted with V-jointed board gates and surmounted by panels of diagonal boarding. The openings are flanked at either end by bays fitted with narrow V-jointed board doors.

The gabled roof is clad in corrugated galvanised steel with cast iron cresting and a central gablet to either side. The eaves are battened and feature a carved timber valance, with a timber valance also on the north and south sides.

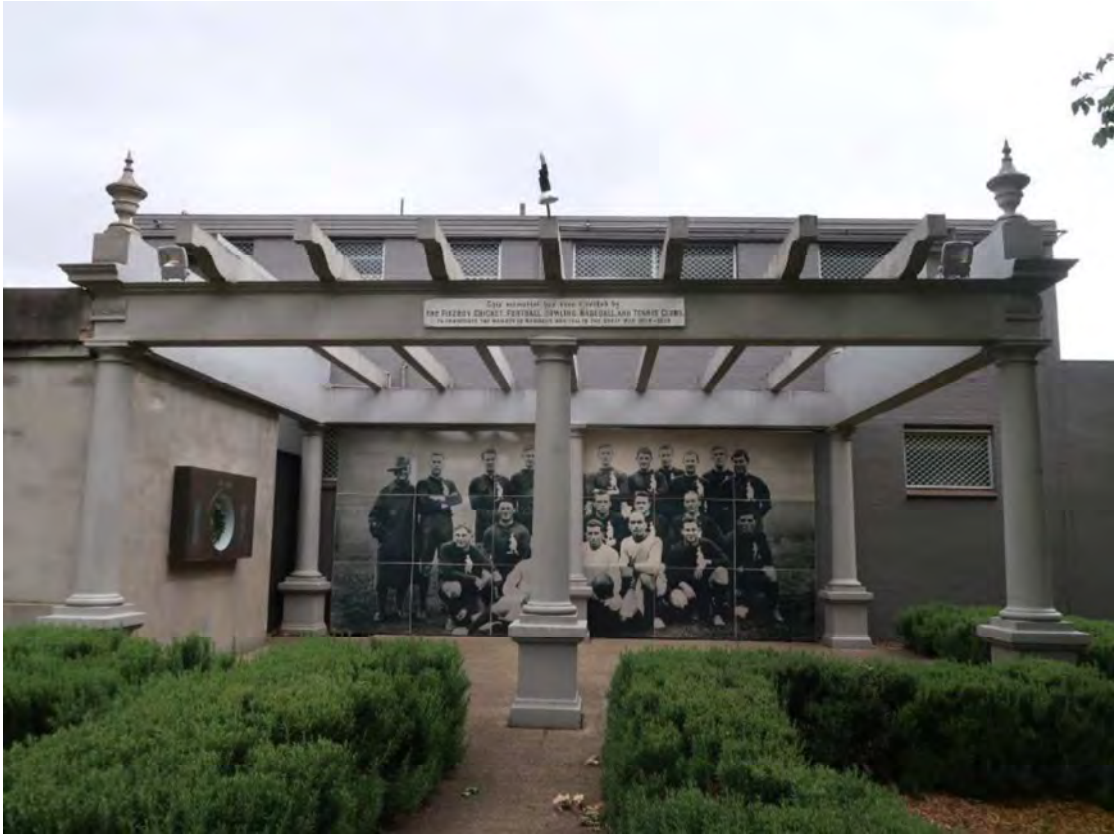
Figure 64 Sportsman's Memorial, looking north, with the Bowling Club building at the rear and substation to the left

The Sportsman's Memorial is a concrete arbour supported by six Tuscan order columns resting on pedestals with simple moulded caps (Figure 64, Figure 65). The perimeter beams have a textured rendered frieze and a moulded cornice and support a series of parallel rafters. The beam to the east elevation contains a central pediment with pressed cement swags surmounted by a moulded cornice. Below the pediment is a recessed panel with the inscription 'IN MEMORIAM' in incised lettering. Urn finials, located at either end of the east beam, have been replaced. On the south elevation, the beam contains a marble plaque which reads: 'THIS MEMORIAL HAS BEEN ERECTED BY THE FITZROY CRICKET, FOOTBALL, BOWLING, BASEBALL AND TENNIS CLUBS TO PERPETUATE THE MEMBERS WHO FELL IN THE GREAT WAR 1914-1919'. The plaque originally appears to have been fixed to the panel on the east elevation. A bronze-framed cabinet for the display of a memorial wreath is fixed to the west wall of the adjacent substation. An exposed aggregate concrete floor has been installed, along with an ornamental arrangement of low trimmed rosemary hedges has been established around it and the approach from the main path. A large image has been printed on the south side of the adjacent Bowls Club and is

The structure exhibits some cracking to the western beam adjacent to the substation.

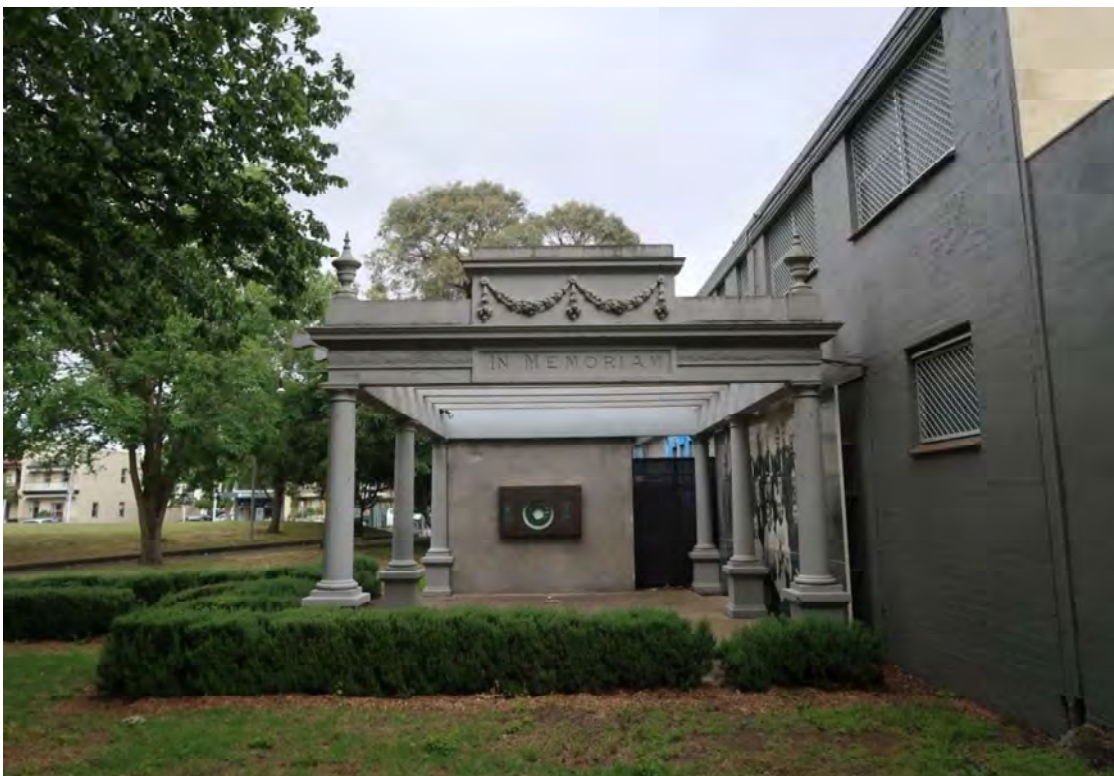
Figure 65 Sportsman's Memorial, looking west; note the Bowling Club abutting the harbour (at right)

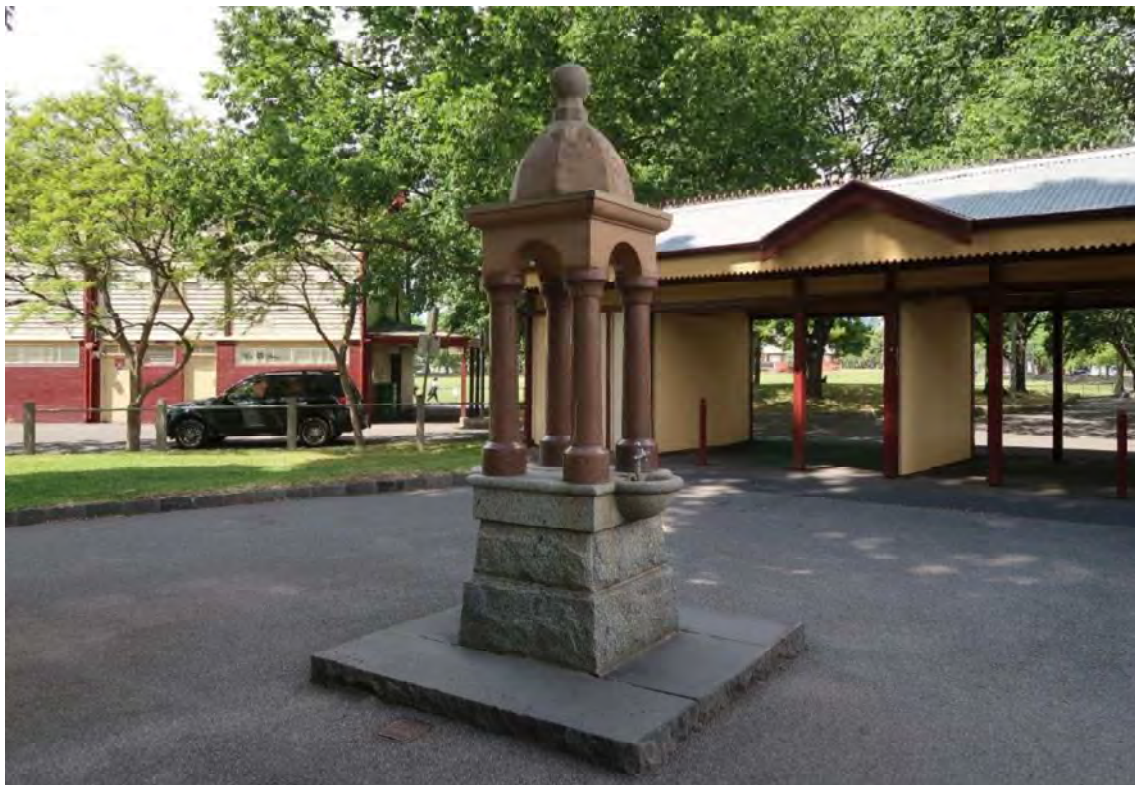
Figure 66 Chandler Drinking Fountain viewed from the north-west

The fountain is in generally sound condition with only minor mortar loss between the two plinth stones and efflorescence to the underside of the arches to the upper section.

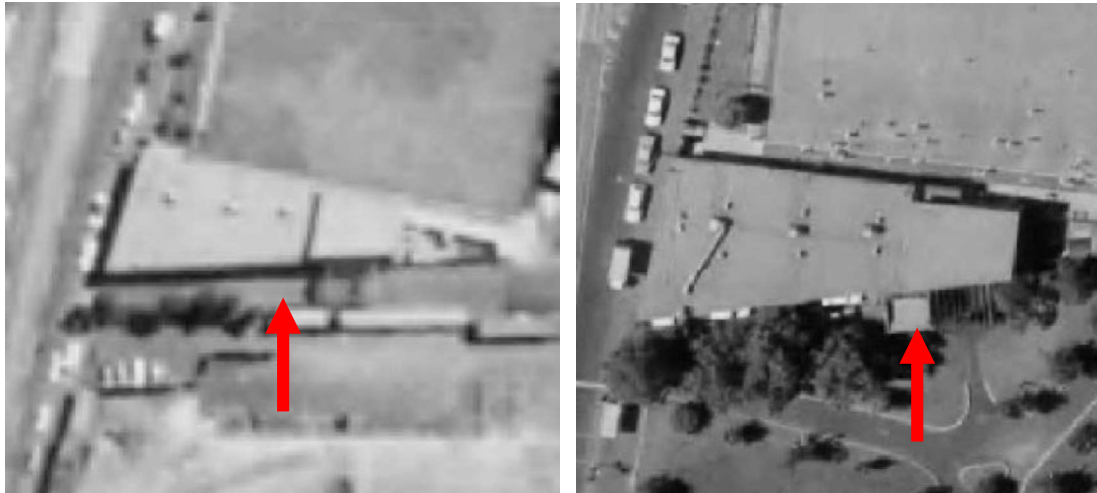
Figure 78 Detail of aerial from 1979 (left) and 1987 (right) with substation visible in the later image but not in the earlier aerial  
Source: Land Victoria

The substation was constructed in the 1980s.

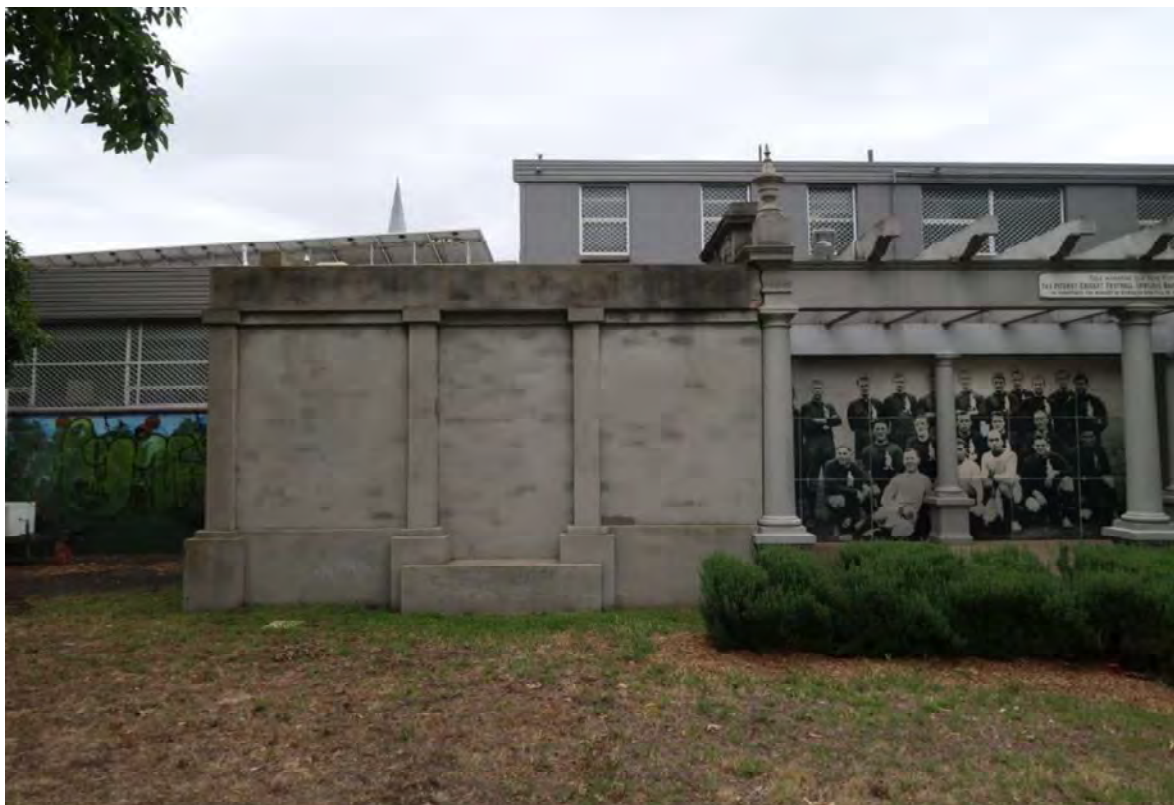
Figure 79 South elevation of the substation

The concrete substation is located to the south of the Bowling Club and abuts the Sportsman's Memorial, creating a symmetrical presentation to the east and west elevations. The substation comprises a monolithic appearance, with square pilasters, a concrete parapet and metal louvres doors on the western side. The building is constructed of brick with a concrete render finish.

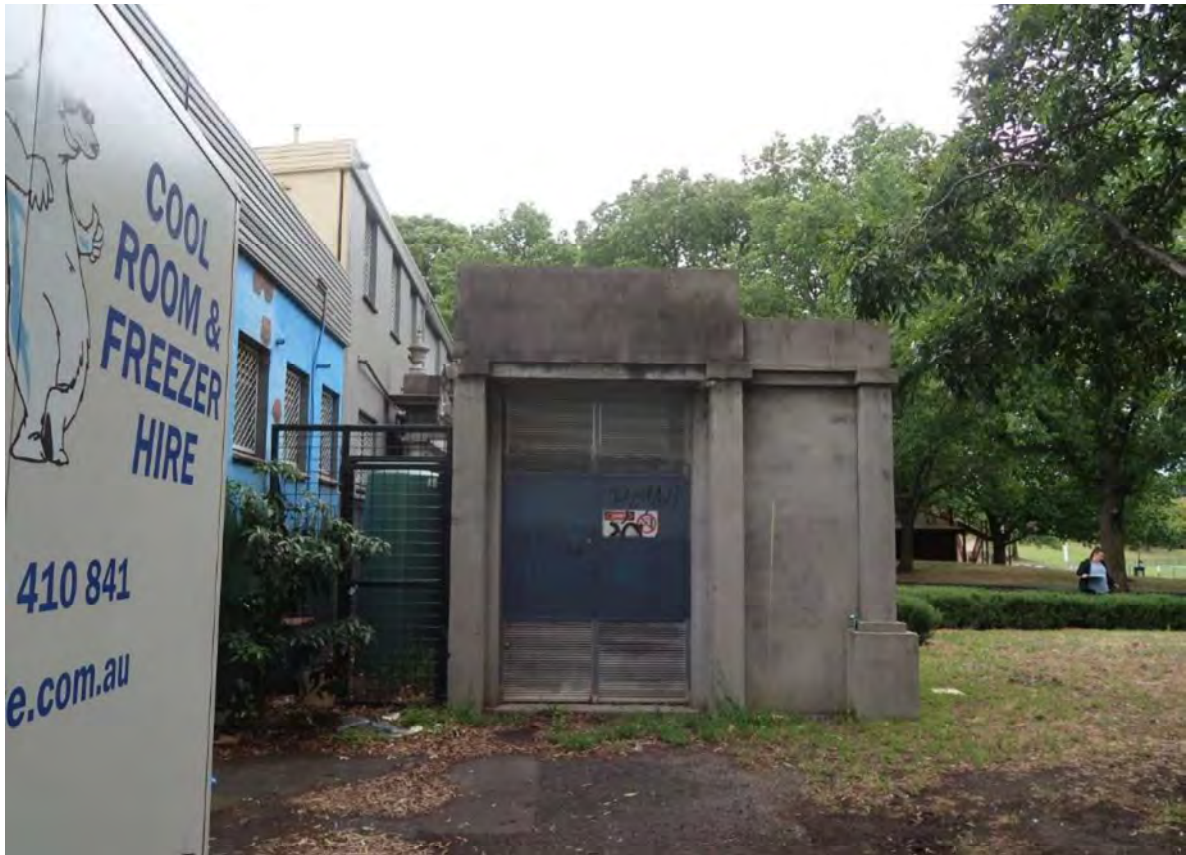
Figure 80 West elevation of the substation

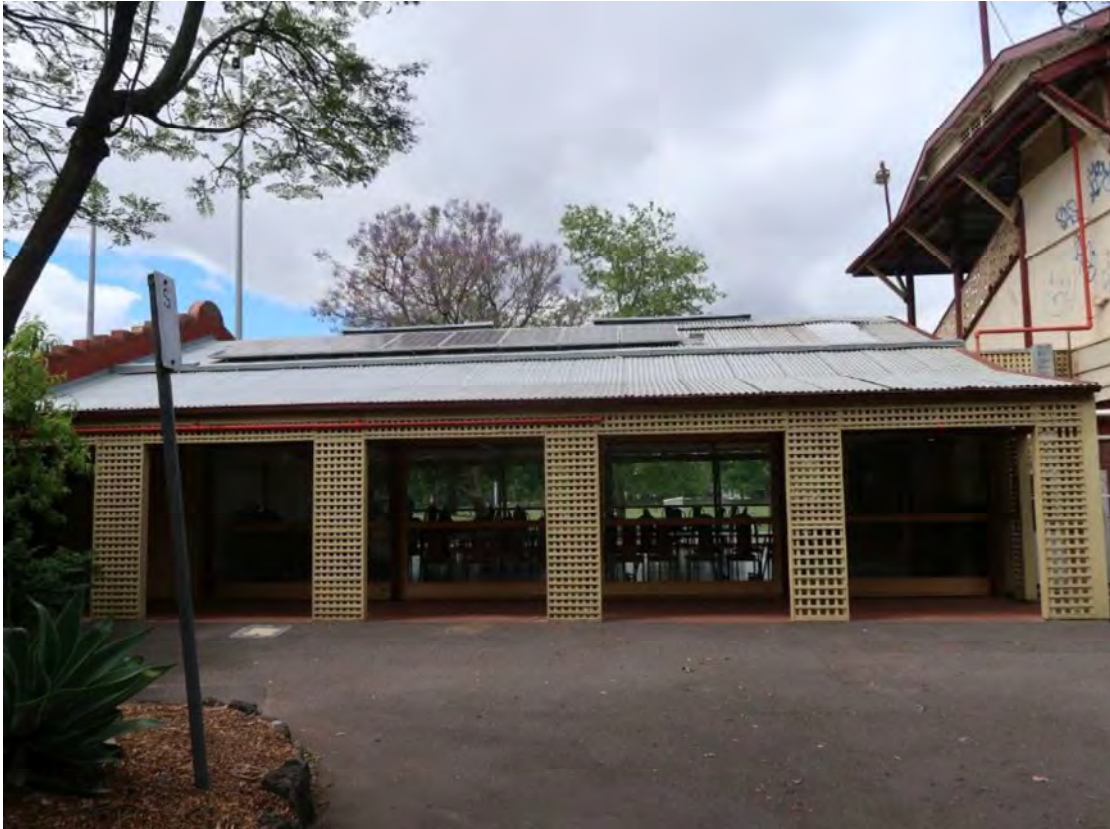
Figure 81 Community Hall viewed from the north

Located to the east side of the grandstand, the Community Hall is a steel and timber-framed building with a gabled roof clad in corrugated galvanised steel. The east elevation comprises a brick wall with a stepped parapet, arched at the apex. Extending across the north of the building is a verandah with timber lattice screens while both the north (Figure 81) and south elevations contain large, timber-framed glazed sliding doors. At the eastern end, the wall is a face red brick wall which directly abuts the rear of the tennis club house buildings.

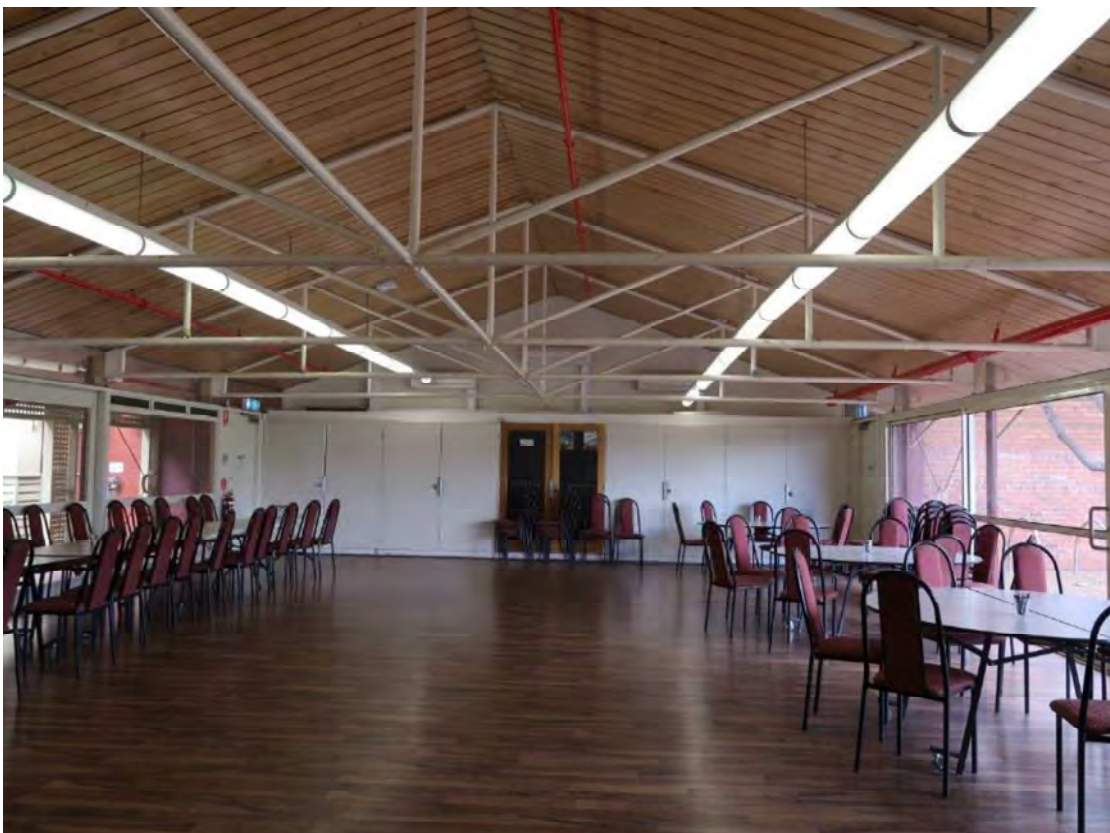
Figure 82 View of the interior of the Community Hall, looking east

Internally, the Community Hall is a lightweight addition, with sliding glazed walls to the north and south elevations (Figure 82). The roof has a low pitch with beaded lining boards and exposed metal trusses to the ceiling internally. Suspended strip lighting extends along each side of the hall. The floor is clad in timber-look linoleum over a concrete slab.

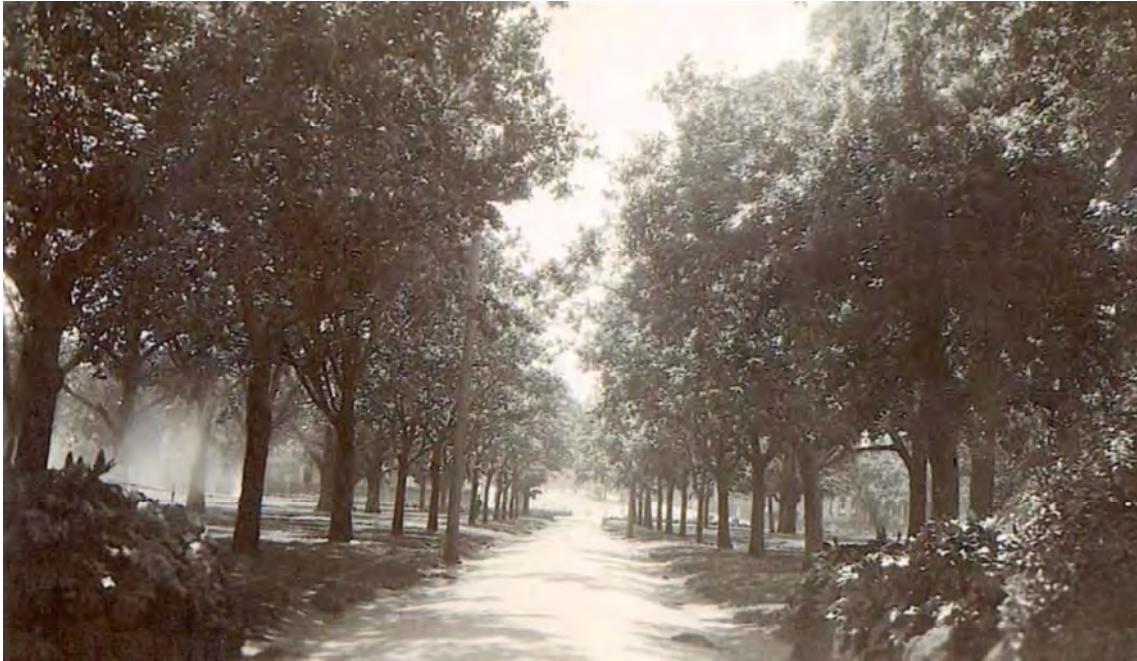
Figure 86 View along a path in the gardens, c. 1927  
Source: Fitzroy Local History Collection

A photograph from the 1920s (Figure 86) shows what would appear to be a major path surfaced with gravel, with a pronounced central crown and trenched gravel gutters to either side. While not determinative, aerial photography of the 1920s-1940s also shows bright pathways which may be considered somewhat more likely to have been a granular rather than a tar or asphalt surface.

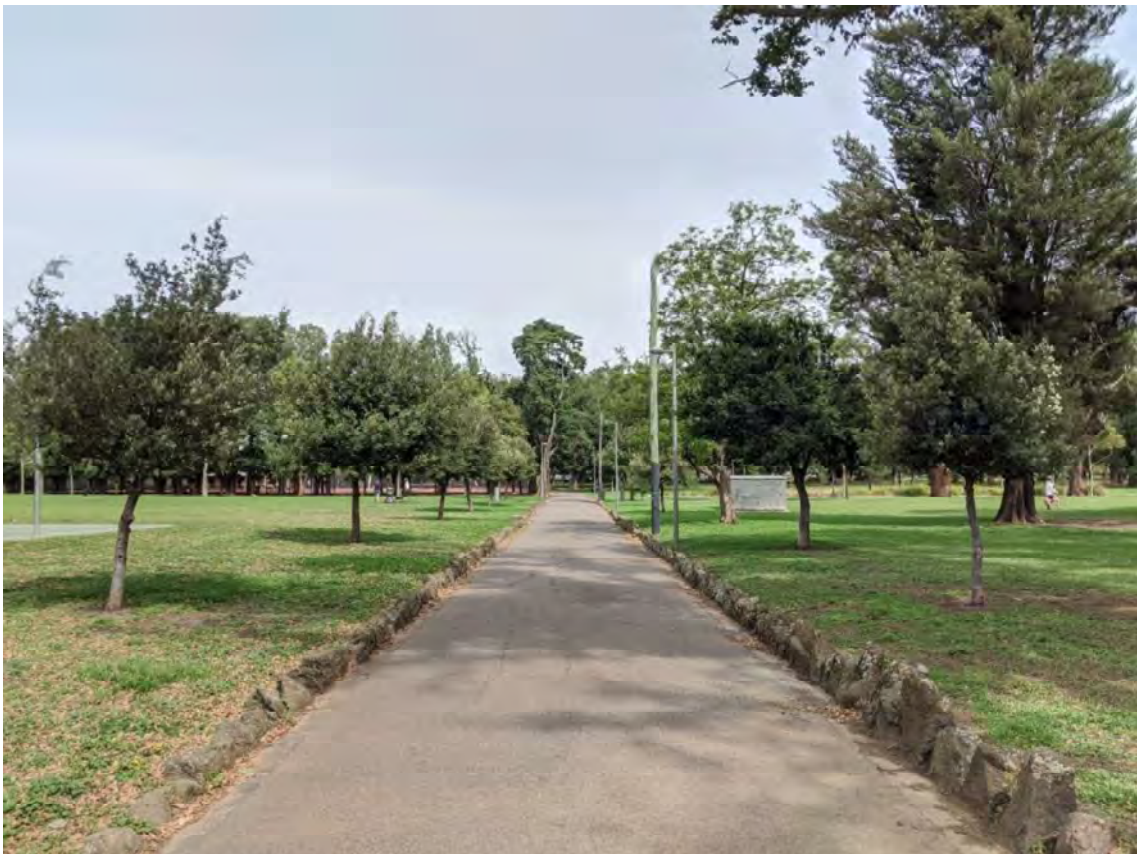
Figure 87 Example of bluestone rubble edging; this form of edging is seen in photographs from the 1920s-1940s, and in many cases served to provide a front edge to garden beds and shrubberies, now removed

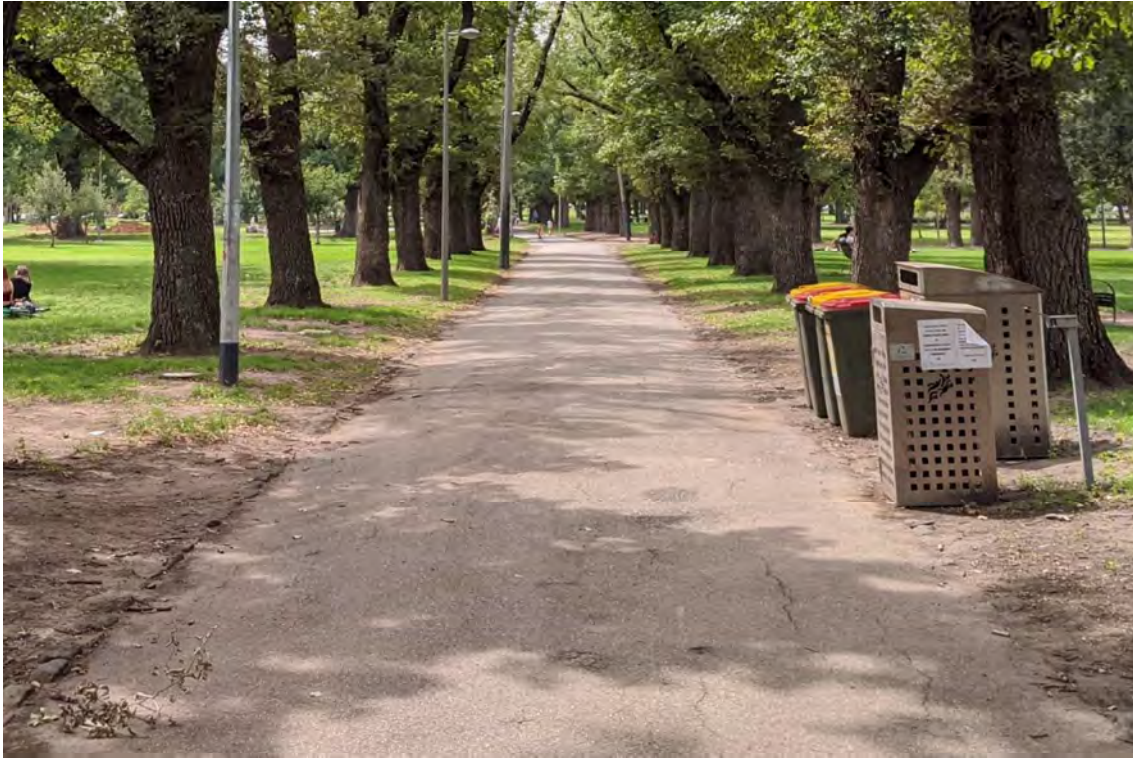
Figure 88 Example of a path with a flush bluestone edge; this edging may have been introduced with modern asphalt paving in the c. 1950s

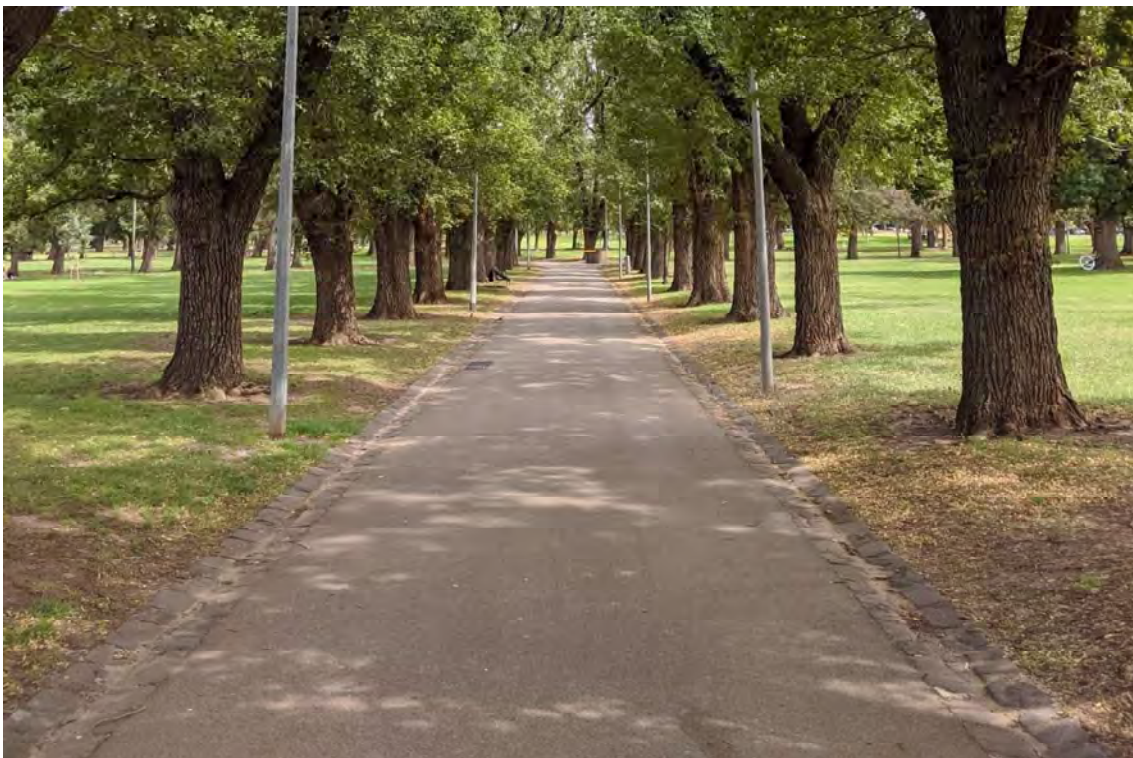
Figure 89 Example of bluestone channel edge without kerbs; similar bluestone channels appear to have been installed in the 1950s-1960s

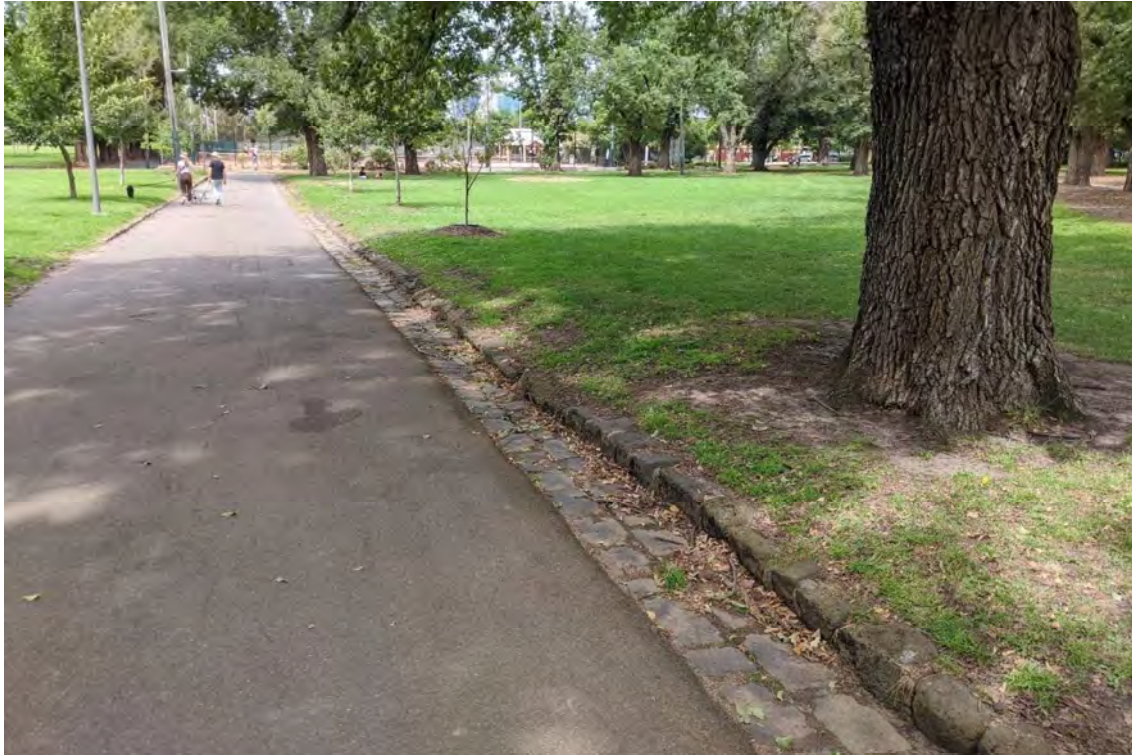
Figure 90 Bluestone channel and edge kerb; this feature appears from aerial photography to have been installed on Avenue A between 1951 and 1969

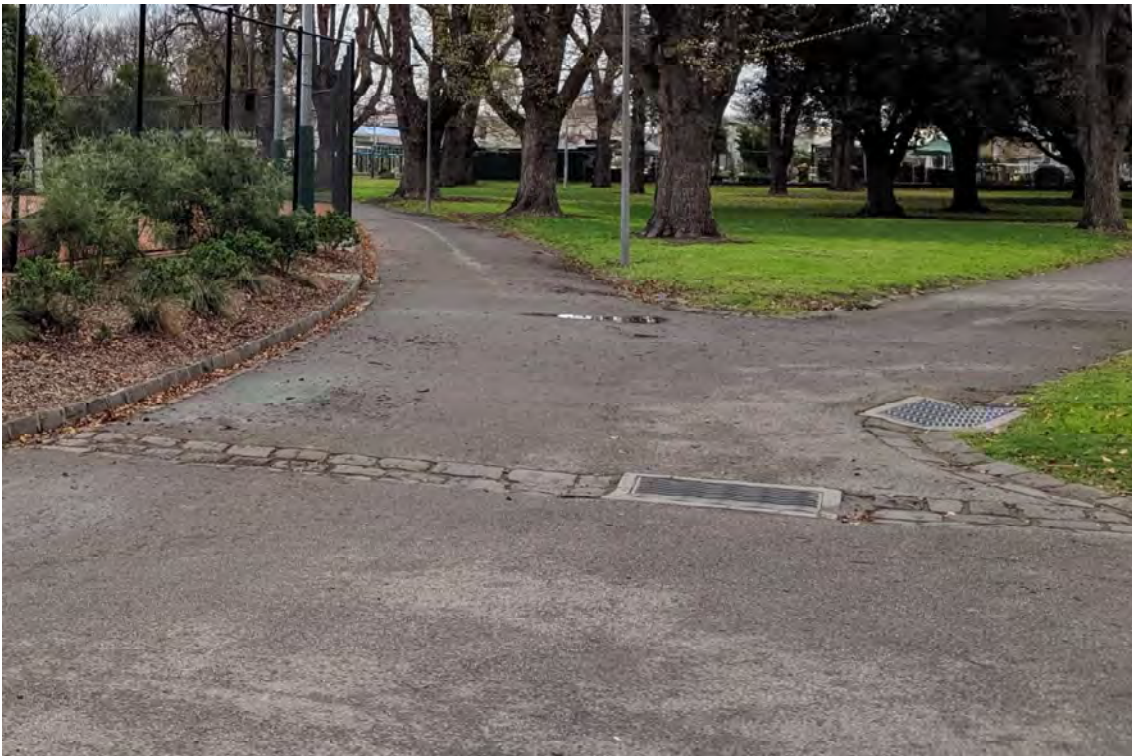
Figure 91 Bluestone channel with later concrete drainage pit at intersection of Avenues A, D and F; aerial photography suggests the channel was installed c. 1950s-1960s

Figure 96 Details from aerial photography of 1945 (top) and 1969 (bottom), showing Avenue D around the former crossing of the railway line, with the former Ladies Bowling Club (current stormwater garden) visible in the centre of the 1969 image; a change in the configuration of the path intersection at the left is visible, including installation of a new bluestone channel (red arrow) seen as a bright line running across the path. Refer Figure 91 for a view of this bluestone channel today.

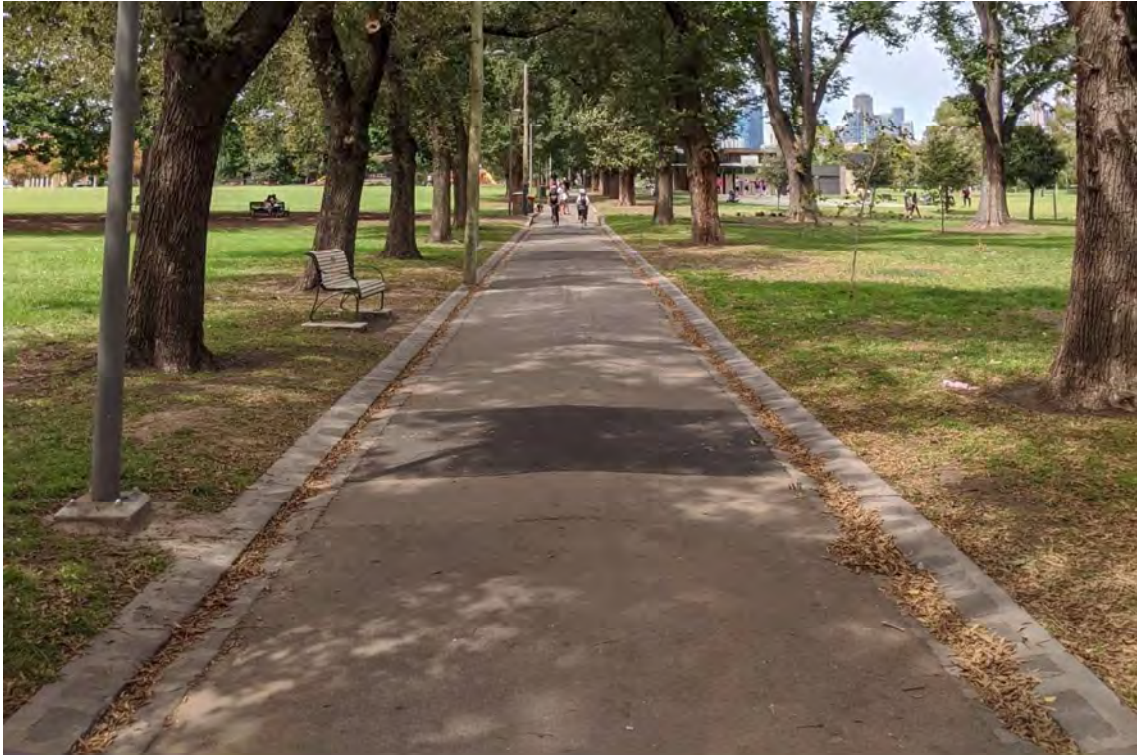
Figure 92 Example of an integrated bluestone kerb and channel, with the outer course raised to form a low kerb above the inner course which serves as the gutter, and heavy concrete mortaring; this edging is likely to date to the c. 1970s

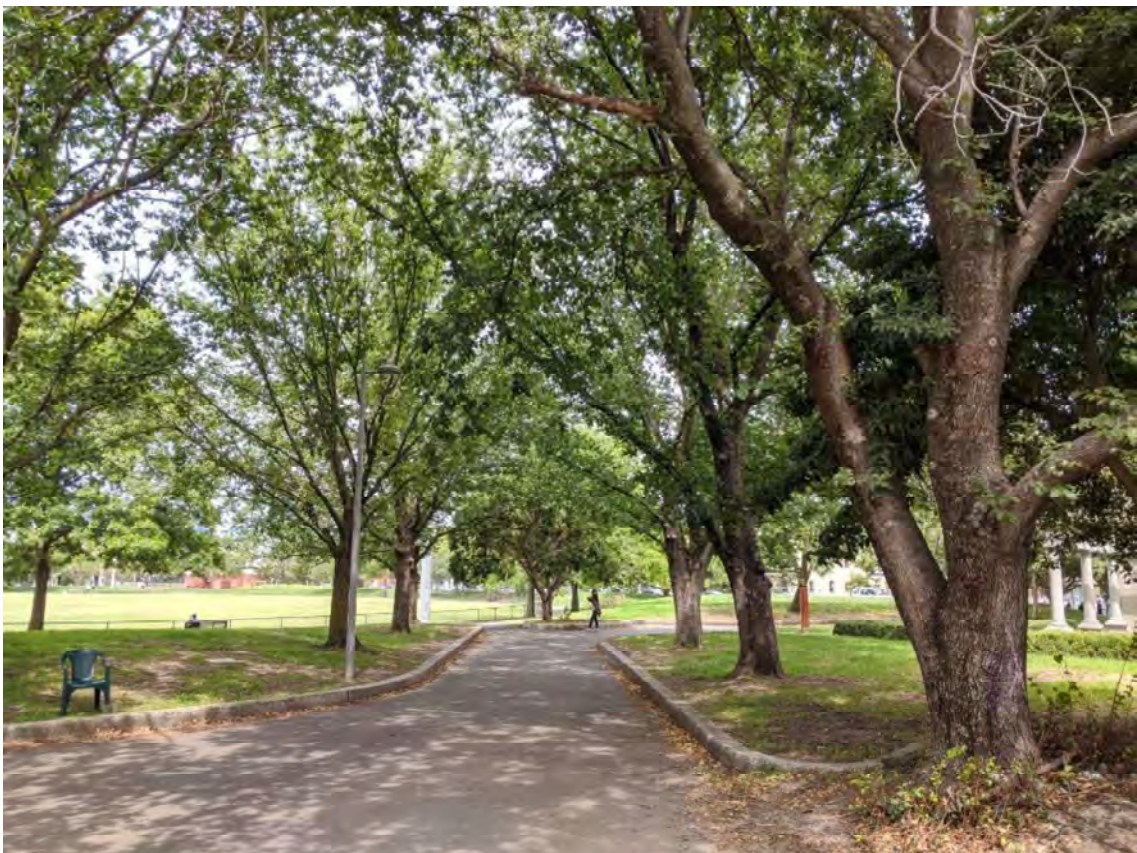
Figure 93 Modern (1980s) concrete kerb in vicinity of the community oval
