### 3.2.3 W. T. Peterson Community Oval – Former Fitzroy Cricket Ground

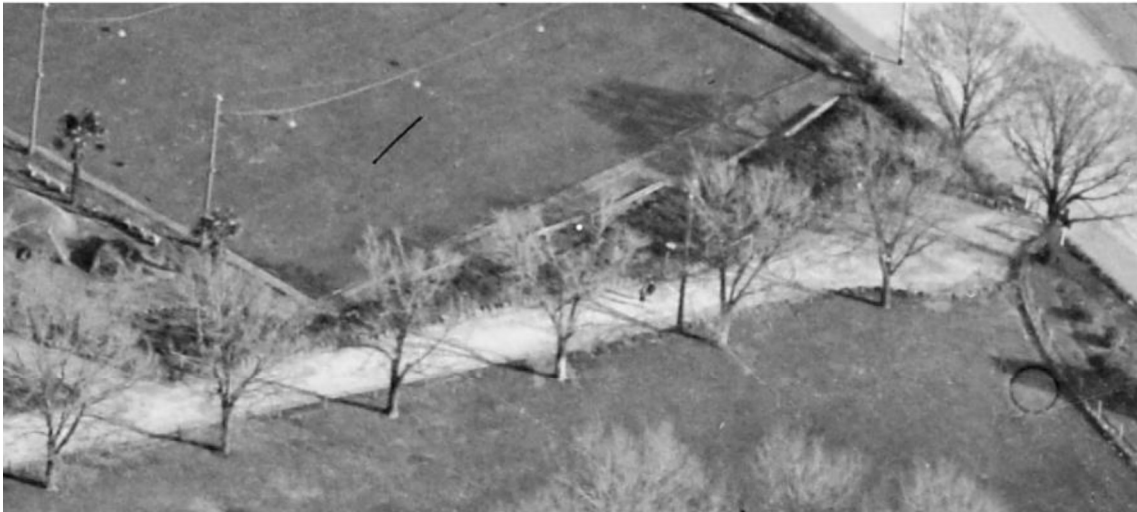
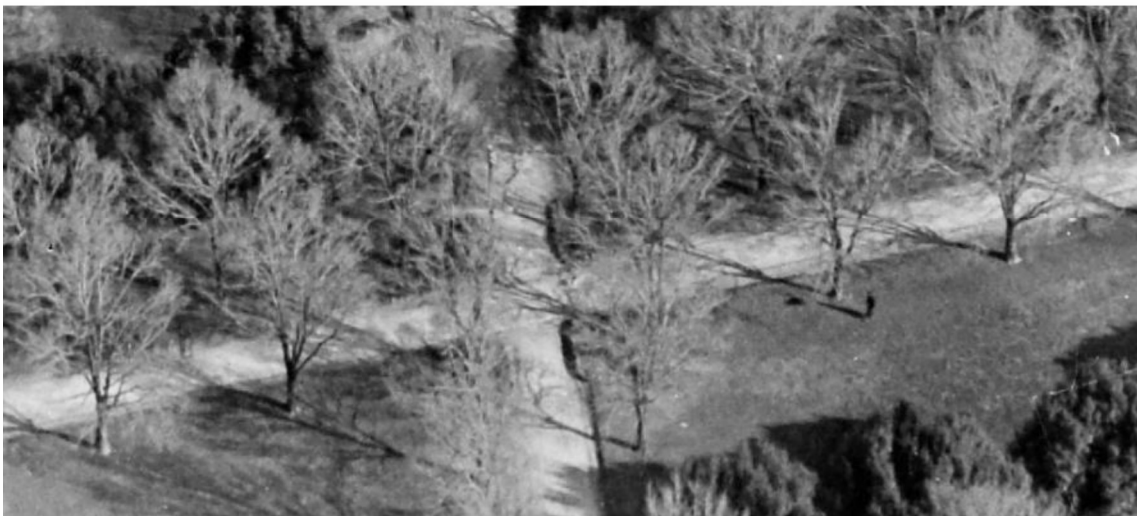
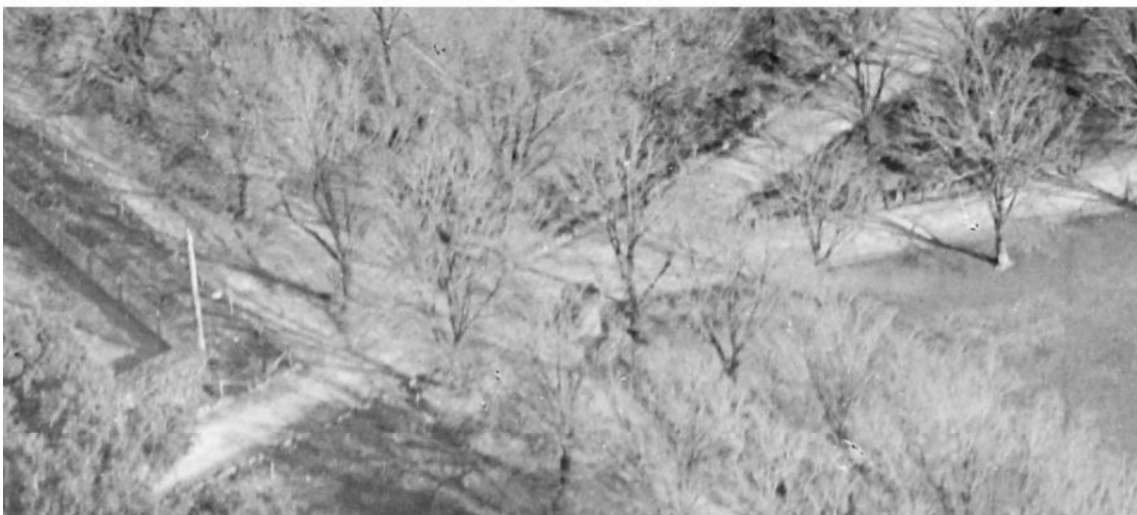
Figure 94 Details from oblique aerial c. 1925-1940, showing apparent granular pathways with sections of bluestone rubble kerb  
Source: C. Pratt, State Library of Victoria

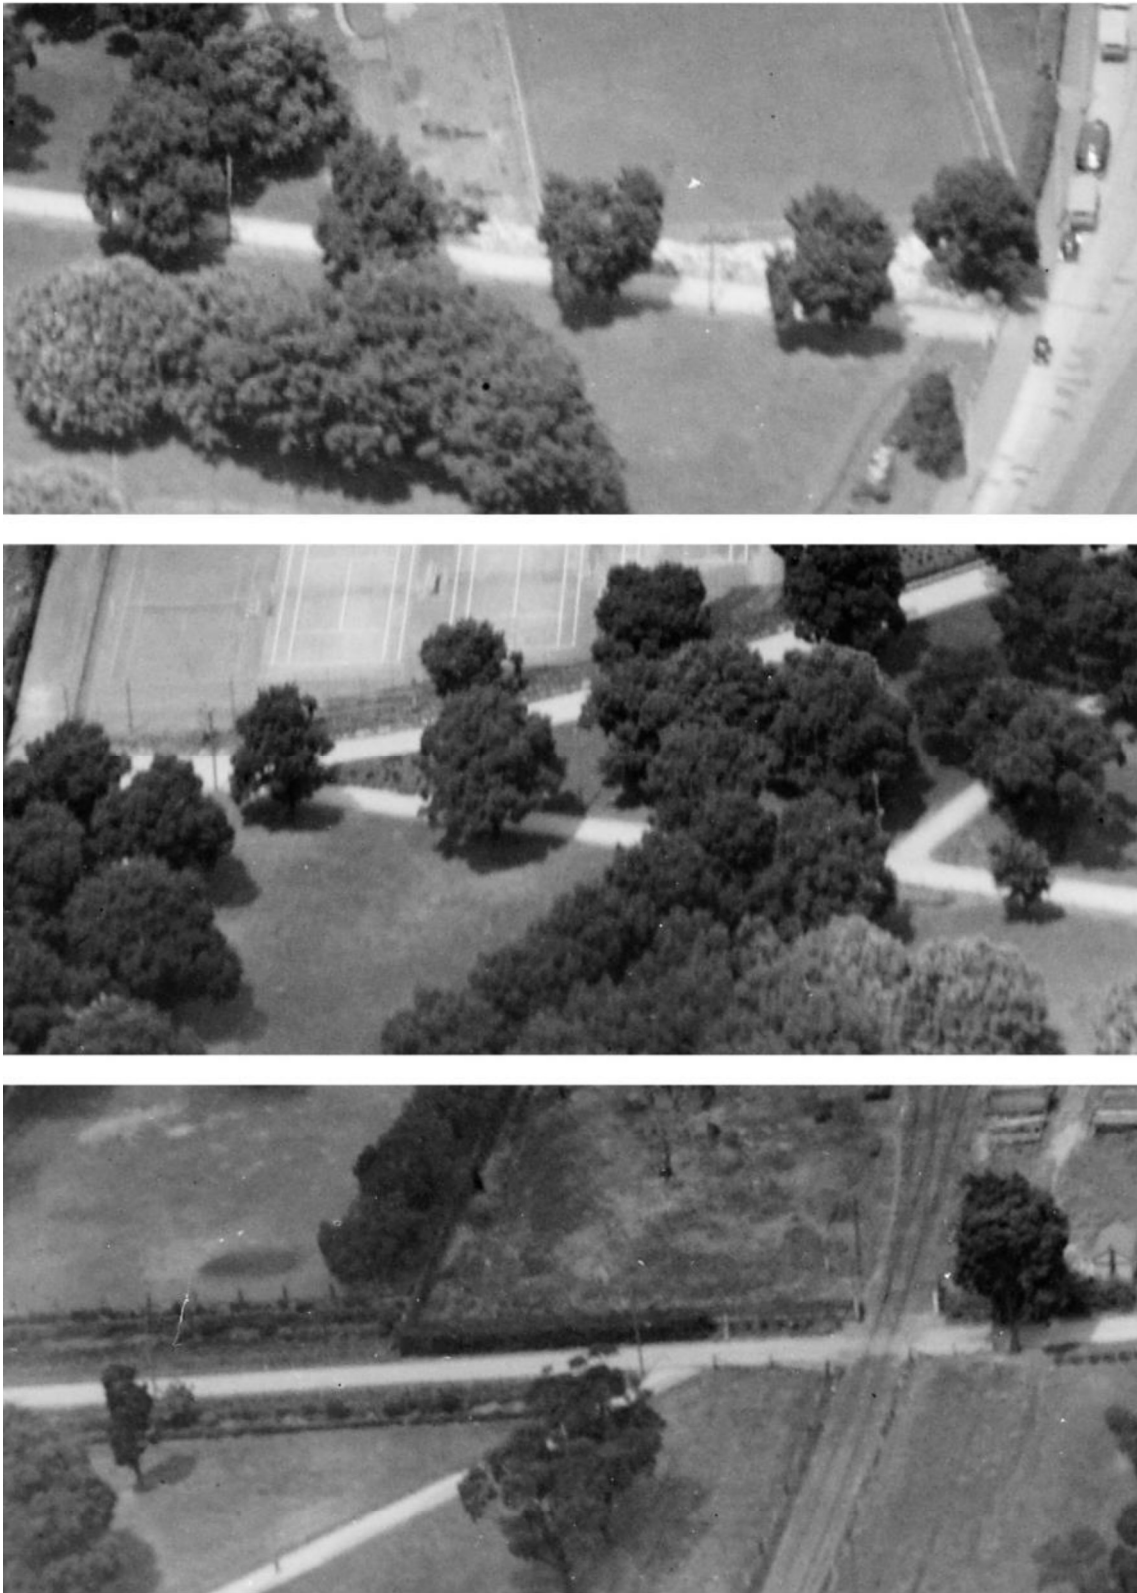
Figure 95 Details from oblique aerial, c. 1930-1940, showing pathway and edging treatments; notable in the top image is the removal of the previously 'flared' entry point at St Georges Road on Avenue F, seen in the previous image.

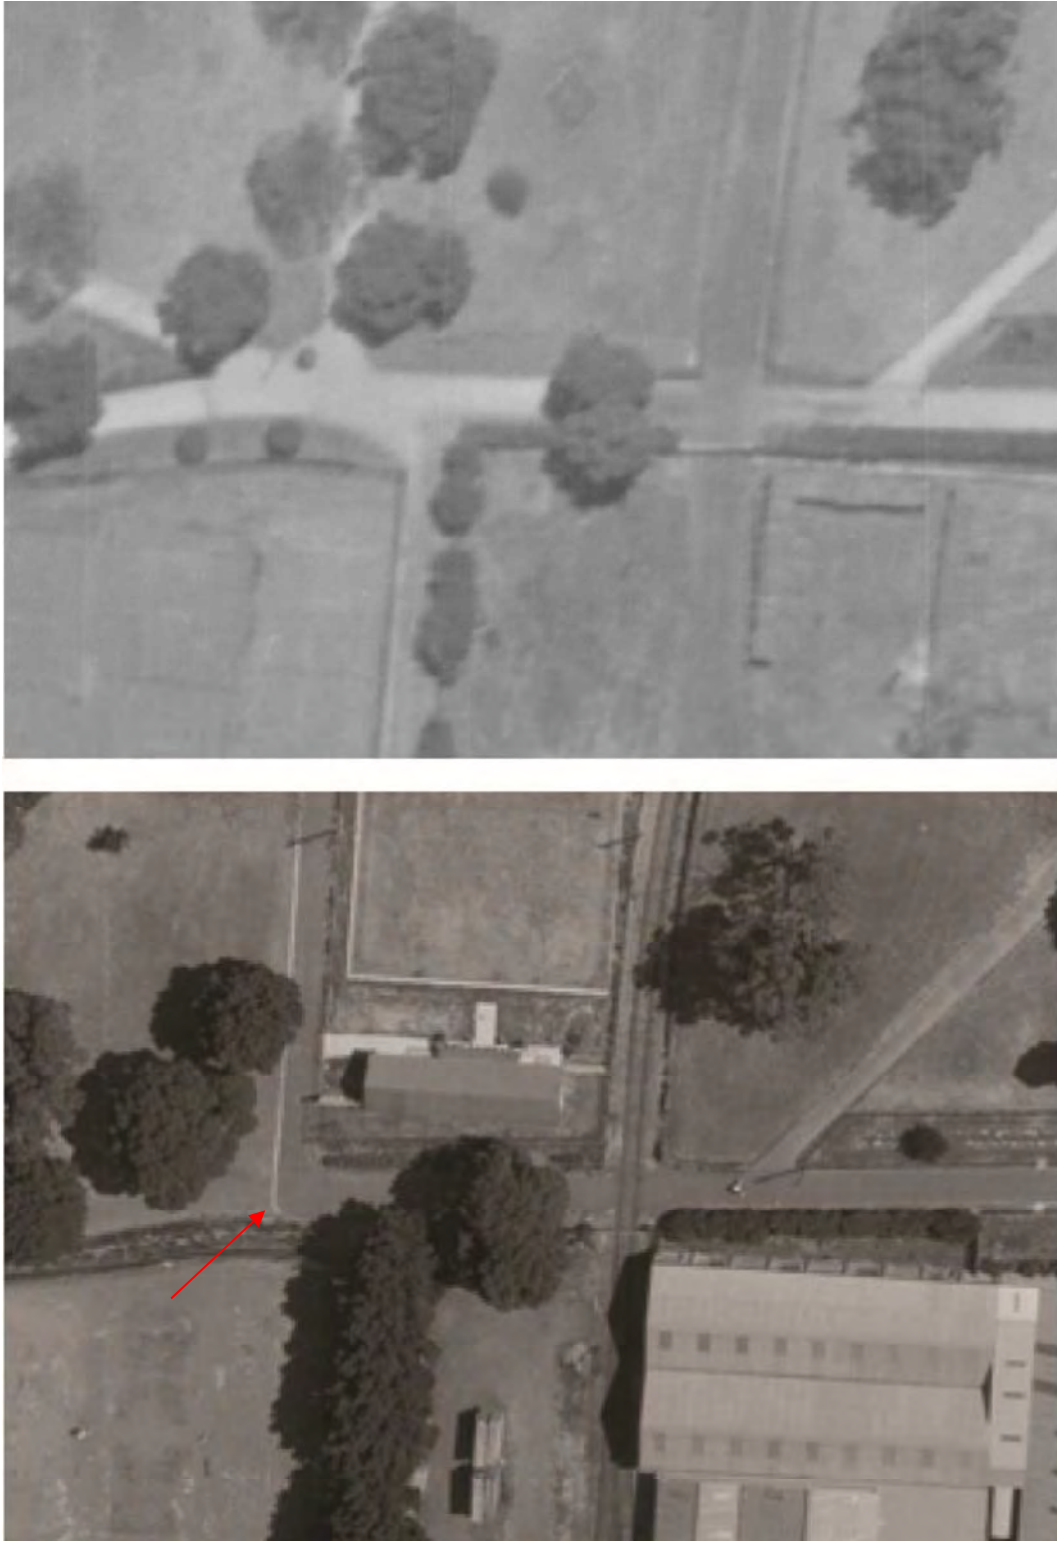
Figure 96 Details from aerial photography of 1945 (top) and 1969 (bottom), showing Avenue D around the former crossing of the railway line, with the former Ladies Bowling Club (current stormwater garden) visible in the centre of the 1969 image; a change in the configuration of the path intersection at the left is visible, including installation of a new bluestone channel (red arrow) seen as a bright line running across the path. Refer Figure 91 for a view of this bluestone channel today.

Certain features can be distinguished as appearing on later aerals where there was no evidence that these were present on earlier images. As an example, the bluestone channel on the west side of Avenue A, north of the tennis courts (Figure 91) appears for the first time on a 1969 aerial image and is not visible on imagery from 1945 and 1951 (Figure 96). Similarly, the integrated bluestone kerb and channel on Avenue E at Alfred Crescent (opposite Falconer Street) does not appear to be visible on the 1969 aerial, and may have been installed after 1969 and before 1987.

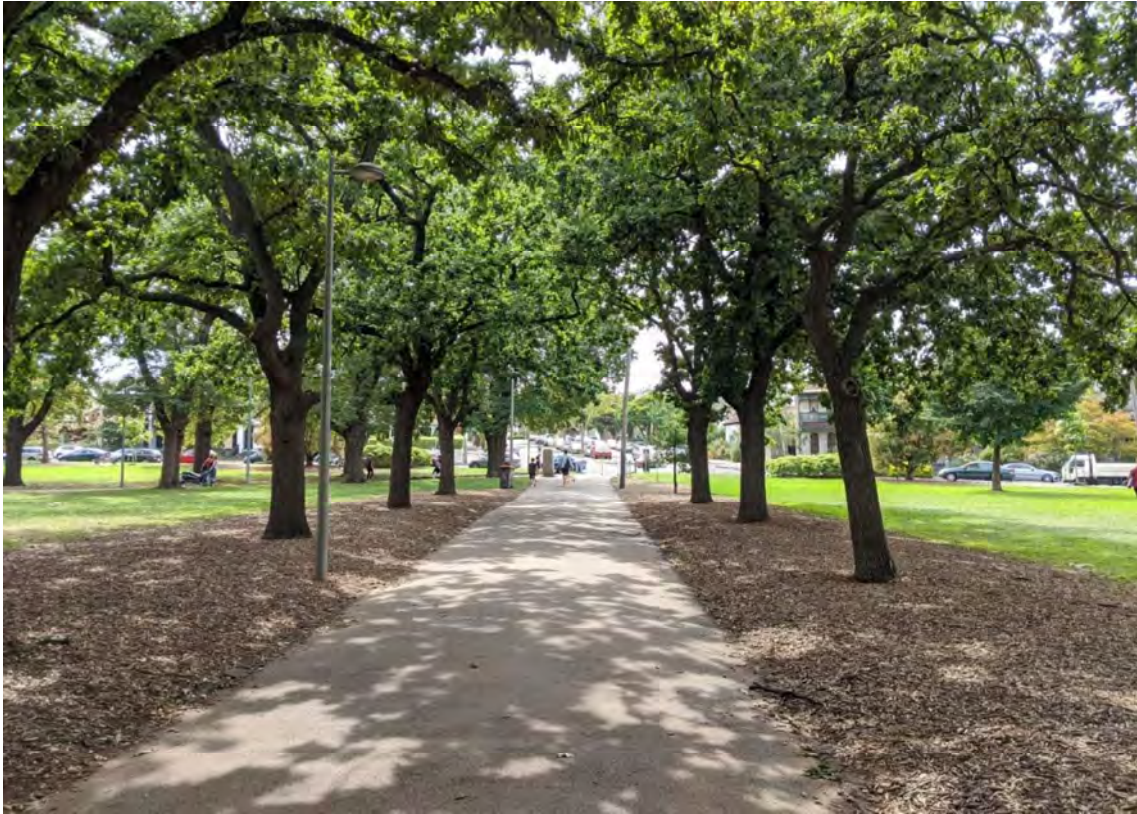
Figure 105 View towards east in avenue of English Oak (*Quercus robur*) (Avenue C) originating at Rowe Street entrance, an original planting of the 1884 avenue system but with trees dating to the late 1940s

A single avenue segment running south-west from Rowe Street is planted with English Oak (*Quercus robur*) (Figure 105). This avenue was originally planted with English Oak in the 1884-85 plantings undertaken by the Committee of Management and reported by Nicholas Bickford. The Oak planting originally continued along further path segments: a NW-SE diagonal path segment that formerly crossed the centre of the park (removed for the railway), and the extent diagonal path from the Reid Street entrance (from which the original avenue was long-removed, but which has recently been replanted with Holm Oak, see below)

Although originally planted with English Oak, the segment from Rowe Street has subsequently been replanted. It is evident from examination of aerial photography that the current Oak trees date to the late 1940s, when they replaced an earlier planting (presumably the original Oaks, but this is not known with certainty). Early aerial photography also makes it clear that both iterations of the avenue were set *to the inside* of additional rows of trees. These appear to have been Southern Mahogany Gum (*Eucalyptus botryoides*), as a single specimen of that species survives south of the English Oak avenue on this alignment and Nicholas Bickford specifically reported having used this arrangement on other avenues in the gardens, with native gums serving as a 'background' to the European avenue trees.

Several young infill specimens are present on the avenue's south row: in the centre where it abuts the remains of an Elm circle north of the Alfred Crescent oval; and at the east end adjacent to the Rowe Street. The trees are relatively small even for their 1940s date, presumably a result of periodic drought stress, constrained soil conditions and competition within the avenue.

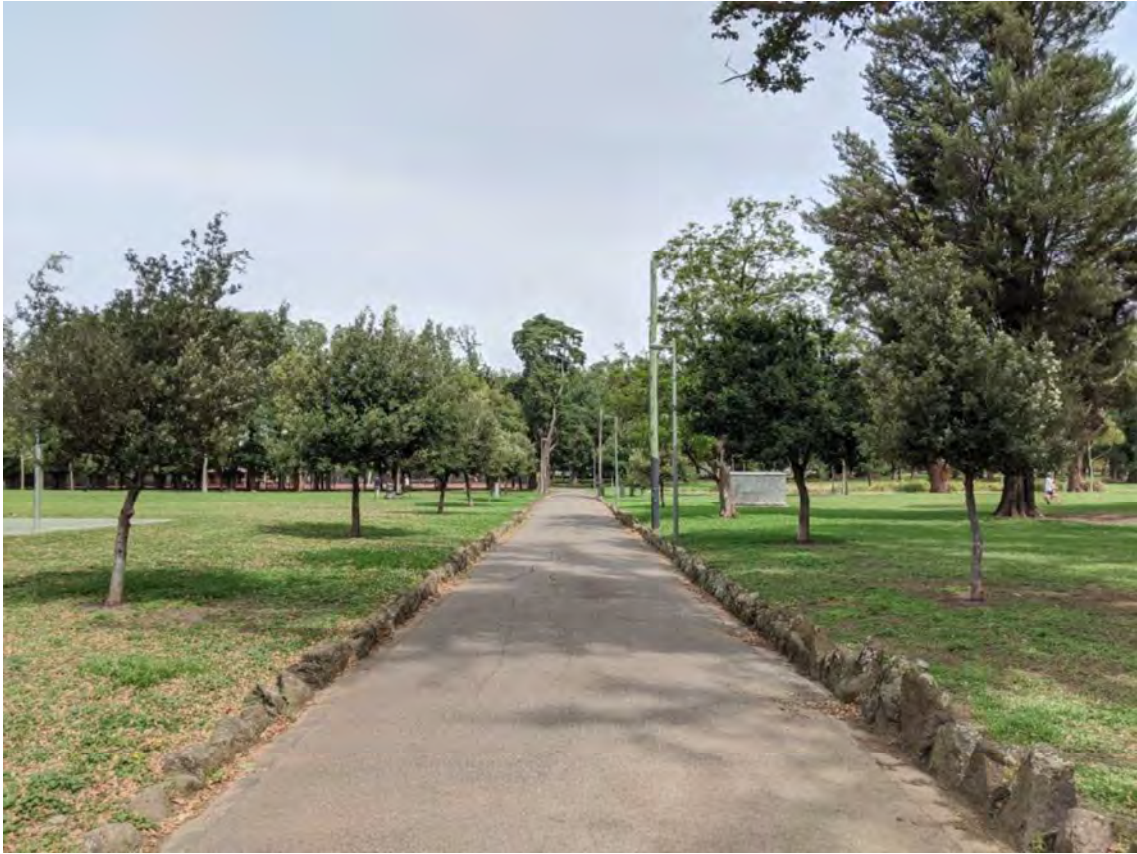
Figure 106 Recently established avenue planting of Holm Oak on a segment of the former 'Evergreen Walk' north of the basketball court

- short path segment west of the English Oak avenue (crossing former railway) (formerly part of the Evergreen Walk, Avenue D) (Figure 106)
- path running south-south-east from the Reid Street / St Georges Road / Alfred Crescent intersection (formerly the north-west segment of the Avenue C English Oak planting) (Figure 107)

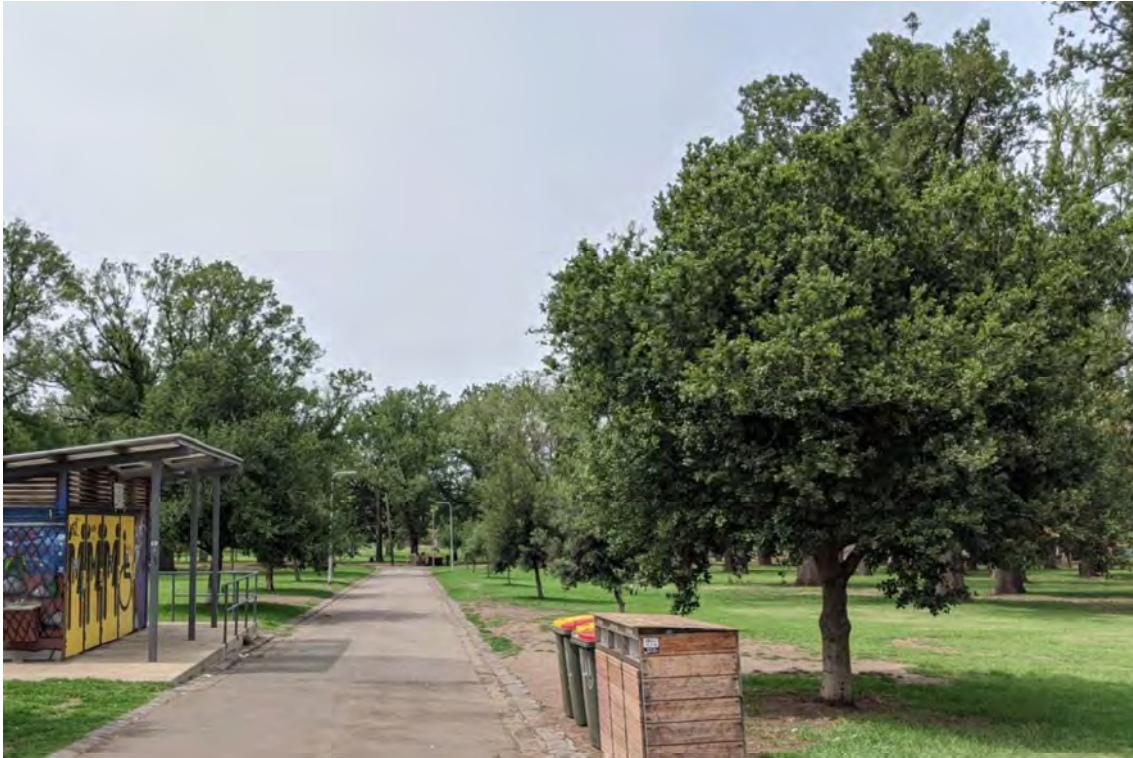
Figure 107 Holm Oak planting (possibly two generations) on the north-west segment of Avenue C, originally an English Oak avenue planted c. 1884

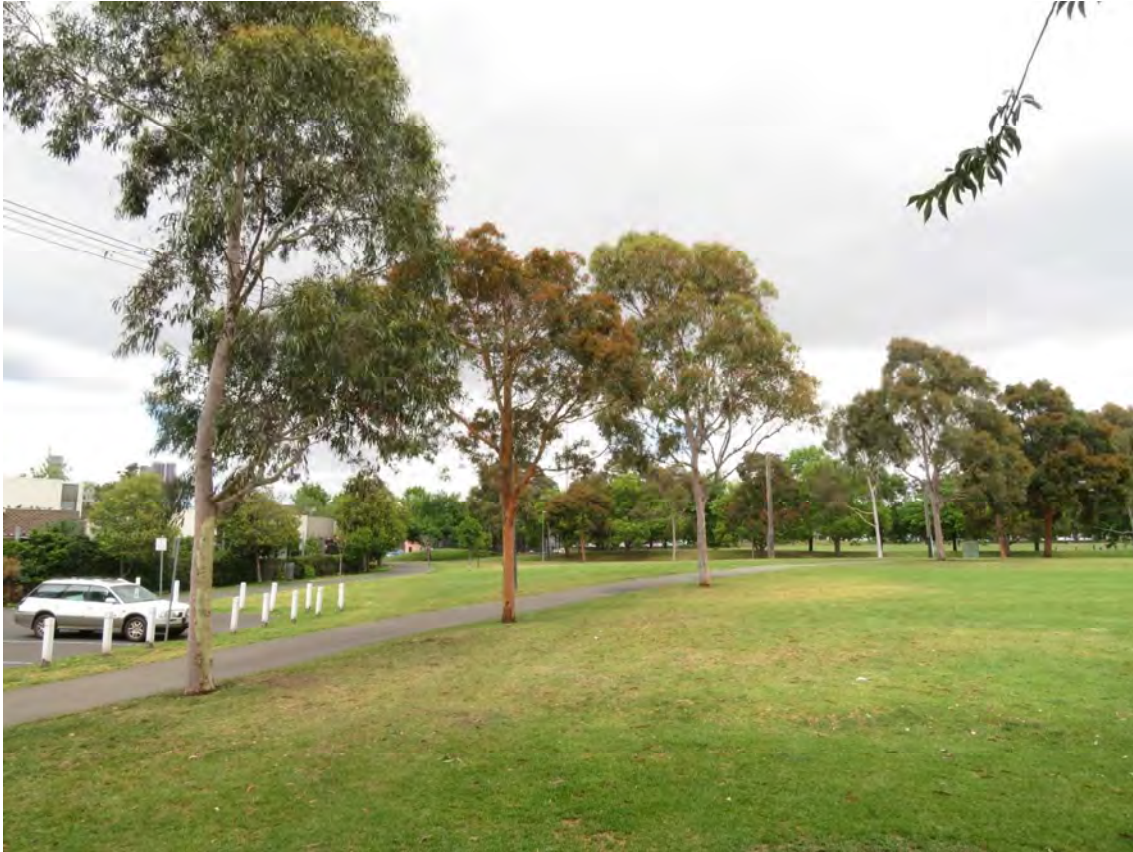
Figure 108 Avenue planting of native gum trees on the curved pathway (Avenue L) installed on the former railway corridor

This avenue is planted with a pair of native Eucalypt species: Smooth-bark Apple (*Angophora costata*) and Lemon-scented Gum (*Corymbia citriodora*) (Figure 108). The outcome has not been completely consistent: some path sections were either only planted to one side or have suffered subsequent failures of planted stock; some sections of the avenue planting have also not established well and are markedly smaller.

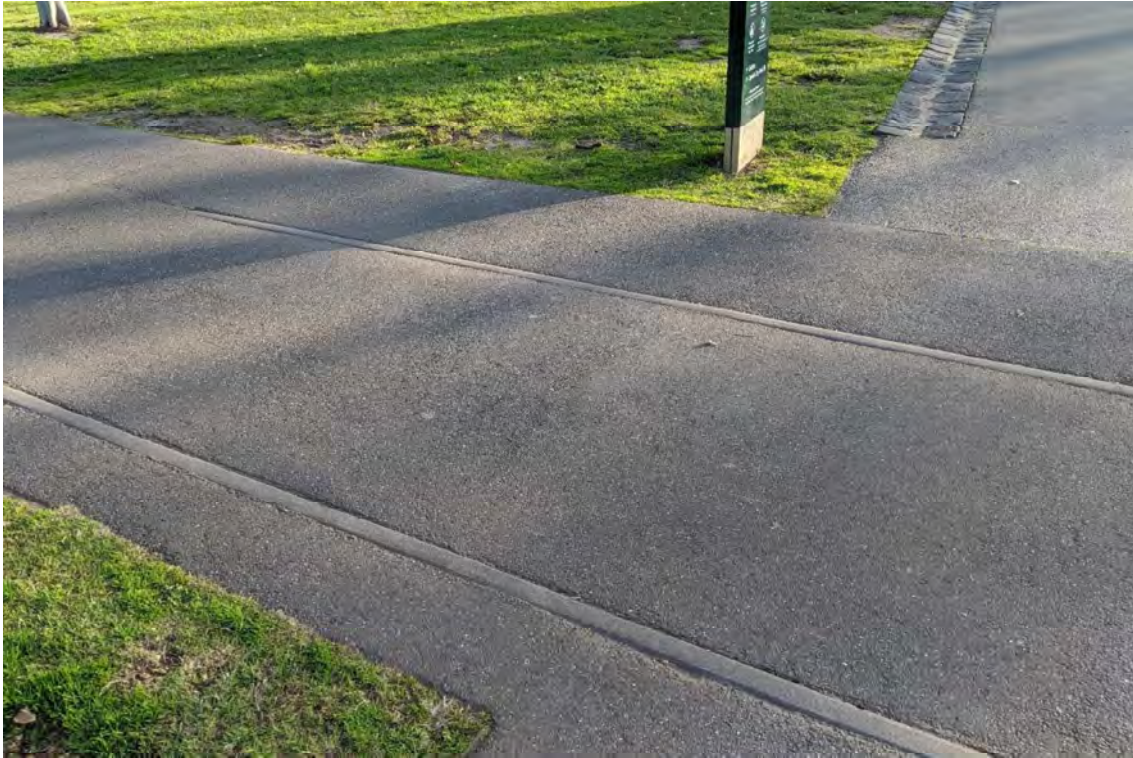
Figure 109 Rails embedded in the pavement of Avenue L in south part of gardens

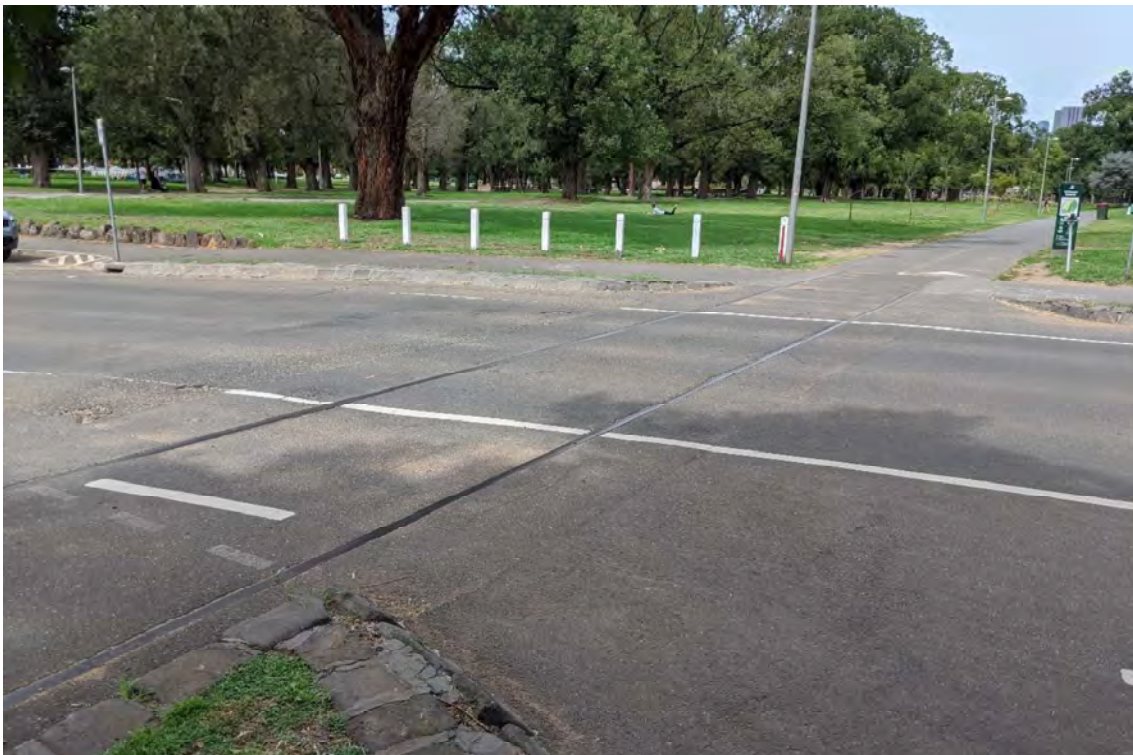
Figure 110 Rails crossing Alfred Crescent, just outside of Edinburgh Gardens

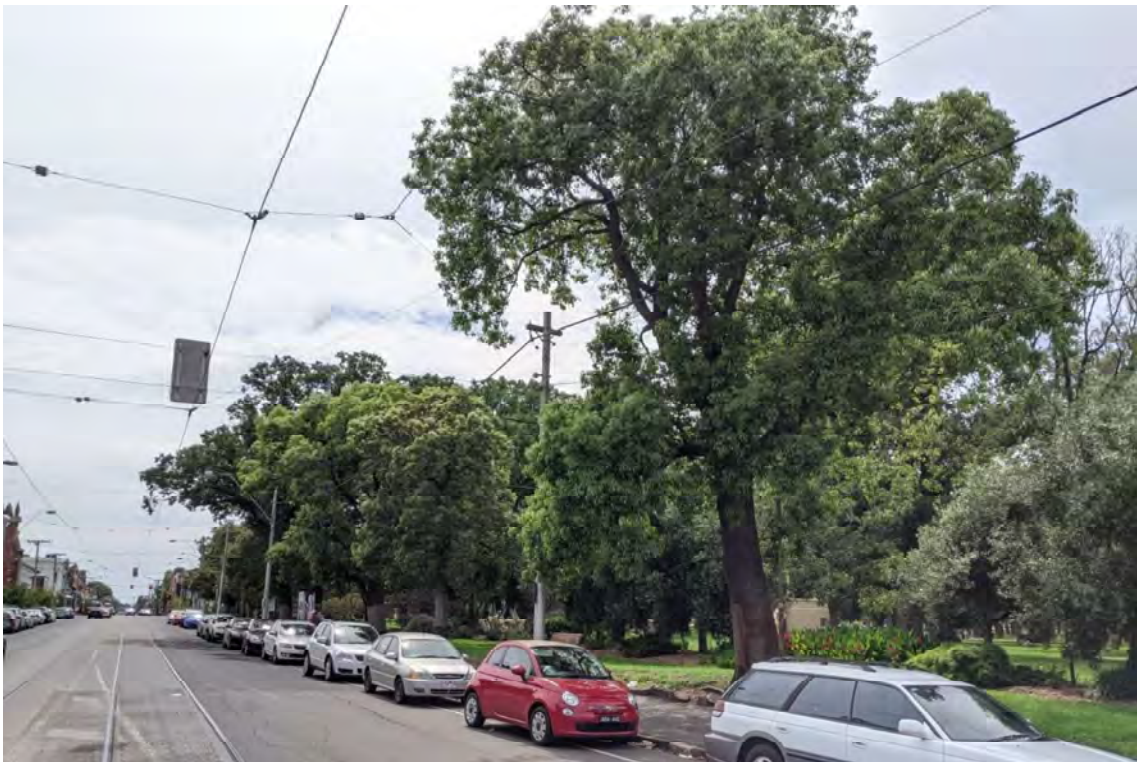
Figure 111 Kurrajong (*Brachychiton propulneus*) row, St Georges Road north from Brunswick Street

Kurrajongs occur in two rows along the west edge of the gardens to St Georges Road and the beginning of Alfred Crescent. Interrupted at the Emely Baker Centre, then again at Best Street by an arc of Desert Ash (*Fraxinus angustifolia*) (refer section 3.5.3), one Kurrajong section runs from Watkins Street to the start of Alfred Crescent (Figure 111 and Figure 112), with the second short row located to the east of the Emely Baker Centre (Figure 113).

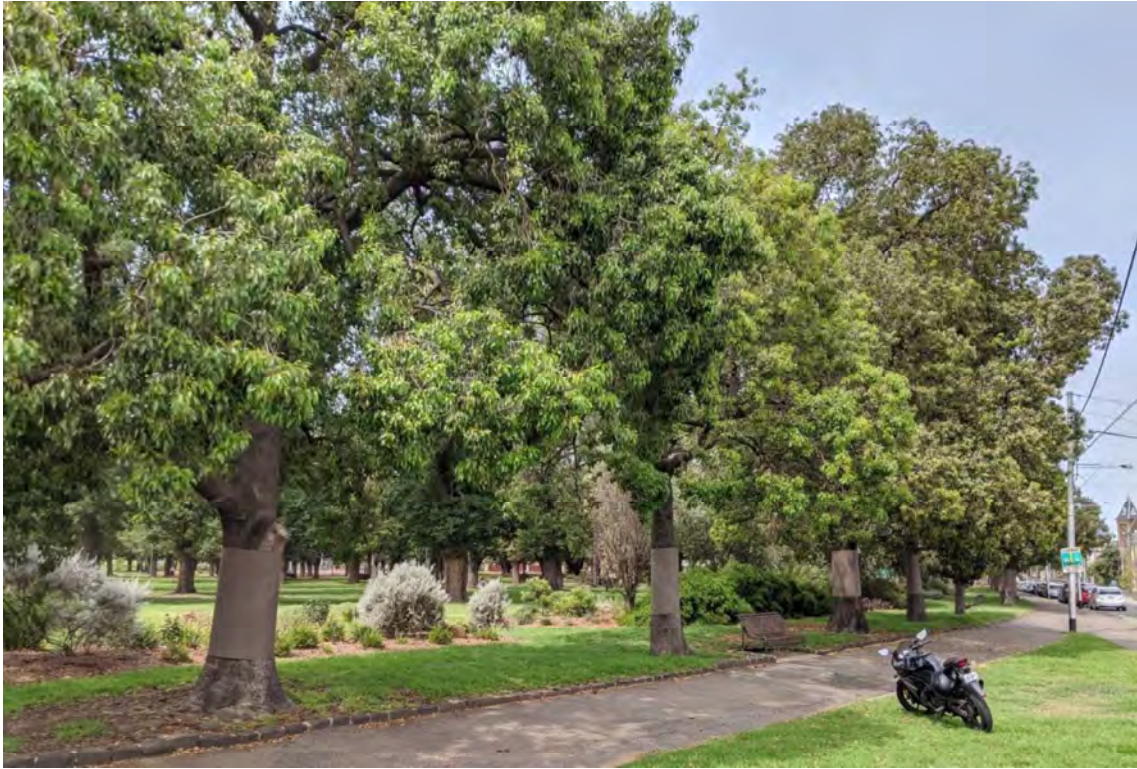
Figure 112 Kurrajong row, St Georges Road south from Alfred Crescent

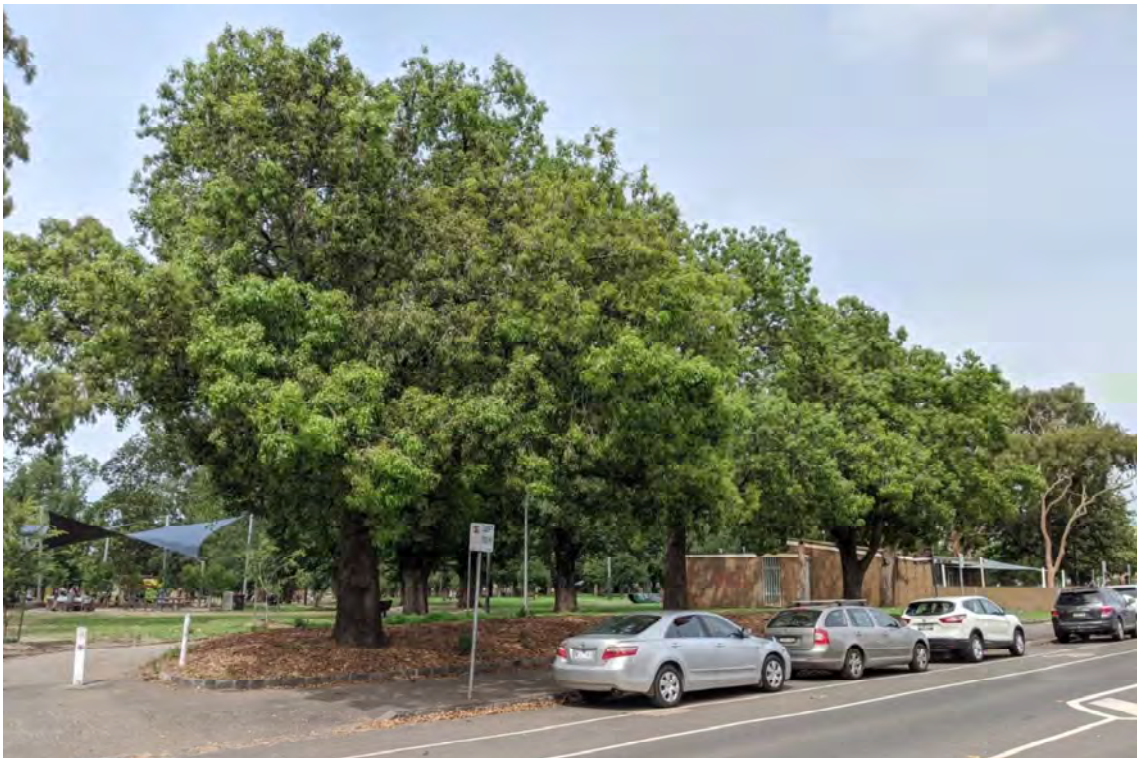
Figure 113 Kurrajong row, east of the Emely Baker Centre on Alfred Crescent

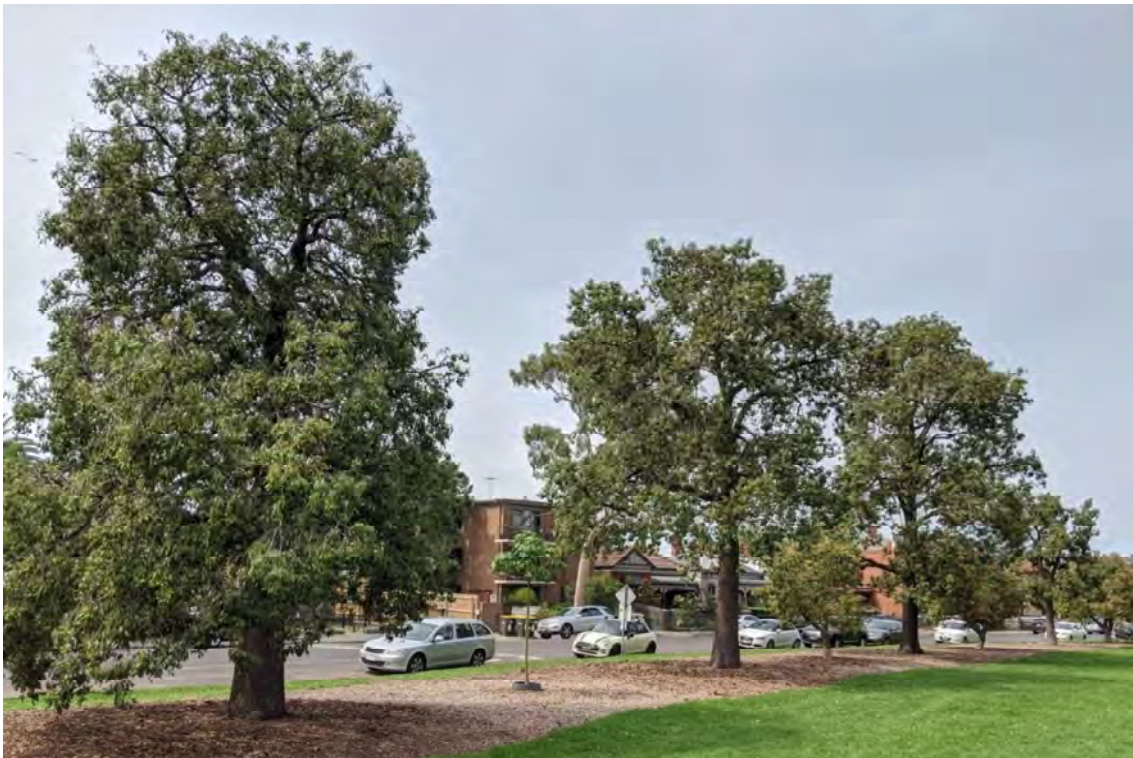
Figure 114 Kurrajong row, with incongruent replacement plantings of Illawarra Flame Tree, beside Alfred Crescent Oval

To the east of the former railway corridor, a row of Kurrajong trees extends south along the gardens' boundary (Figure 114 and Figure 115). Infill plantings of other types of *Brachychiton* were established to

fill gaps in the Kurrajong row, mostly south of Rowe Street where the original planting had suffered significant attrition presumably due to soil and moisture conditions. The first infills appear to have taken place between 1987-2003, particularly at the south end of the row beside the Alfred Crescent Oval (Figure 116) and employed a hybrid cultivar (*Brachychiton populneus x acerifolius*) that is broadly similar in mature form to the neighbouring Kurrajongs. More recent infills within the row have employed Illawarra Flame Tree (*Brachychiton acerifolius*); still juvenile trees, once mature these plantings will be less congruent in their formal appearance to the original Kurrajong trees and may have consequences for the overall perception of this planting as a historical and aesthetic feature.

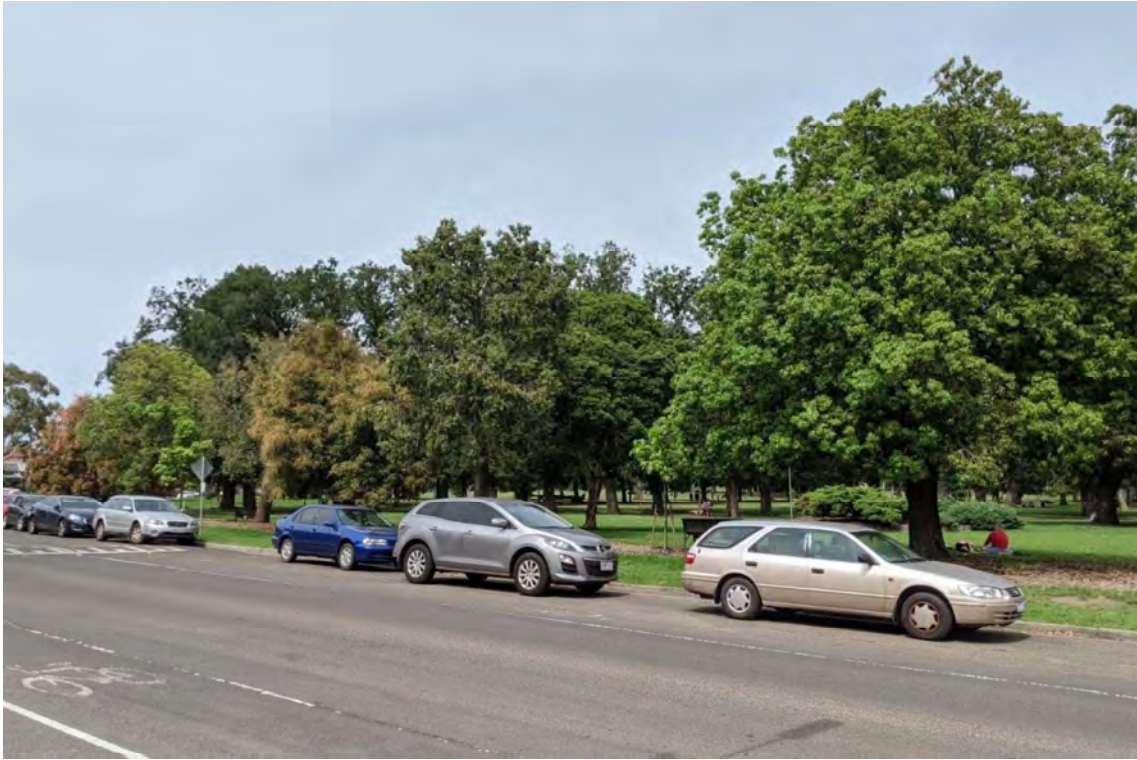
Figure 115 Kurrajong row, with infill plantings, on Alfred Crescent near Falconer Street

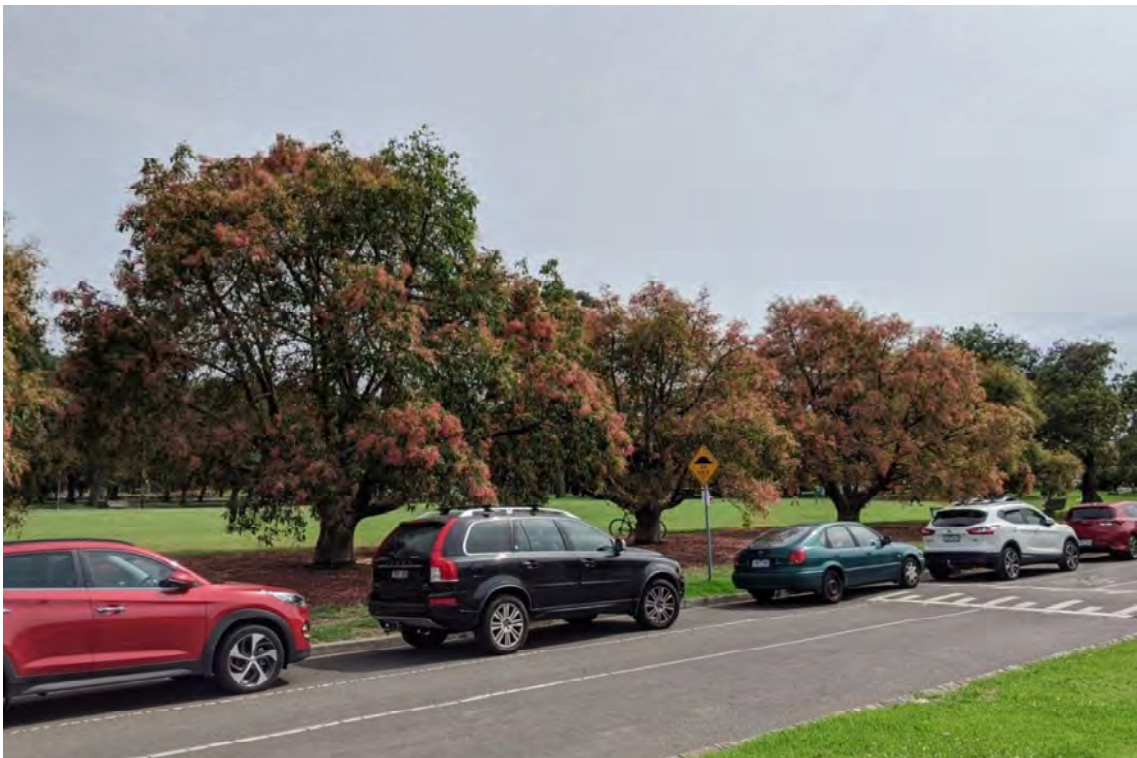
Figure 116 Older hybrid *Brachychiton* planting in flower at the south end of the Alfred Crescent Kurrajong row; other than the obvious difference in flowering time and colour, the hybrid cultivar otherwise presents as broadly congruent with the original Kurrajong trees in form and spatial effect

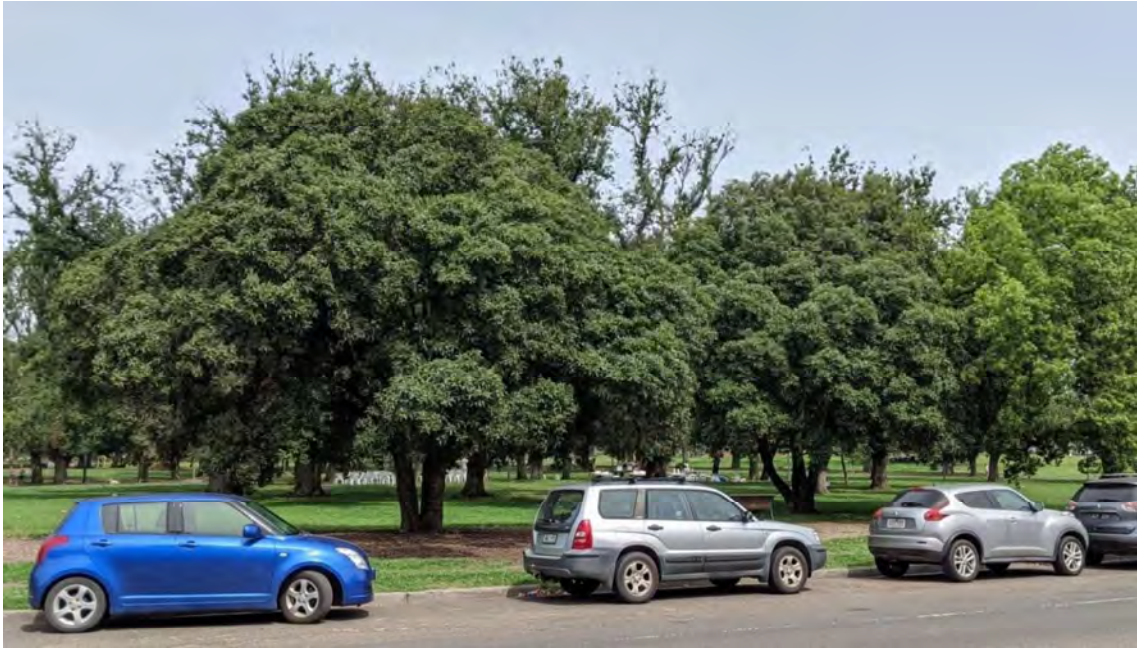
Figure 117 Two specimens of Sweet Pittosporum within and adjacent to the present Kurrajong row are likely remnants of the c. 1881 'Pines and Pittosporums' row/avenue planting that encircled Edinburgh Gardens in the first decades after its formal planting

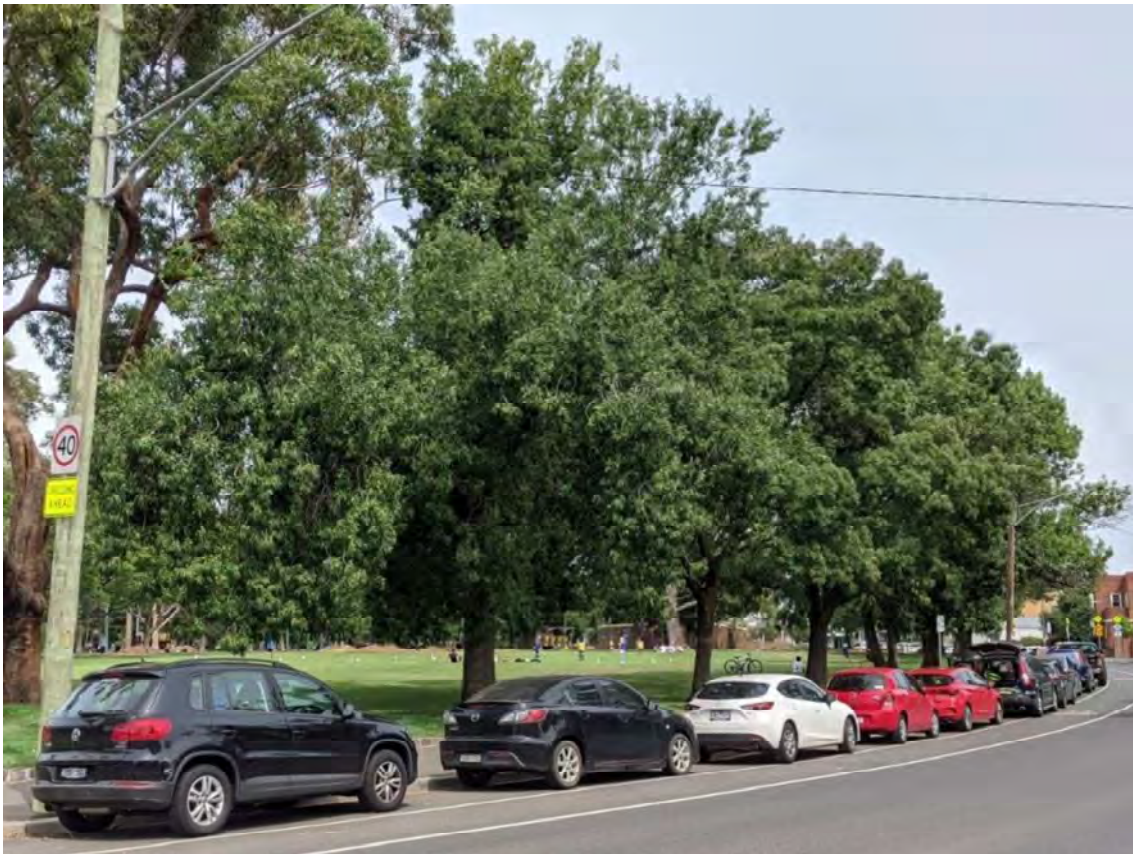
Figure 119 Desert Ash row on Alfred Crescent, a c. 1960 planting

A short row of nine mature Desert Ash (*Fraxinus angustifolia*) and one Claret Ash (*Fraxinus angustifolia* 'Raywood') is present along the northern frontage of the Gardens to Alfred Crescent (Figure 119), opposite the Primary School.

The Ash row appears to have been established in the 1960s, as it is visible at a juvenile scale in aerial photography from 1969.

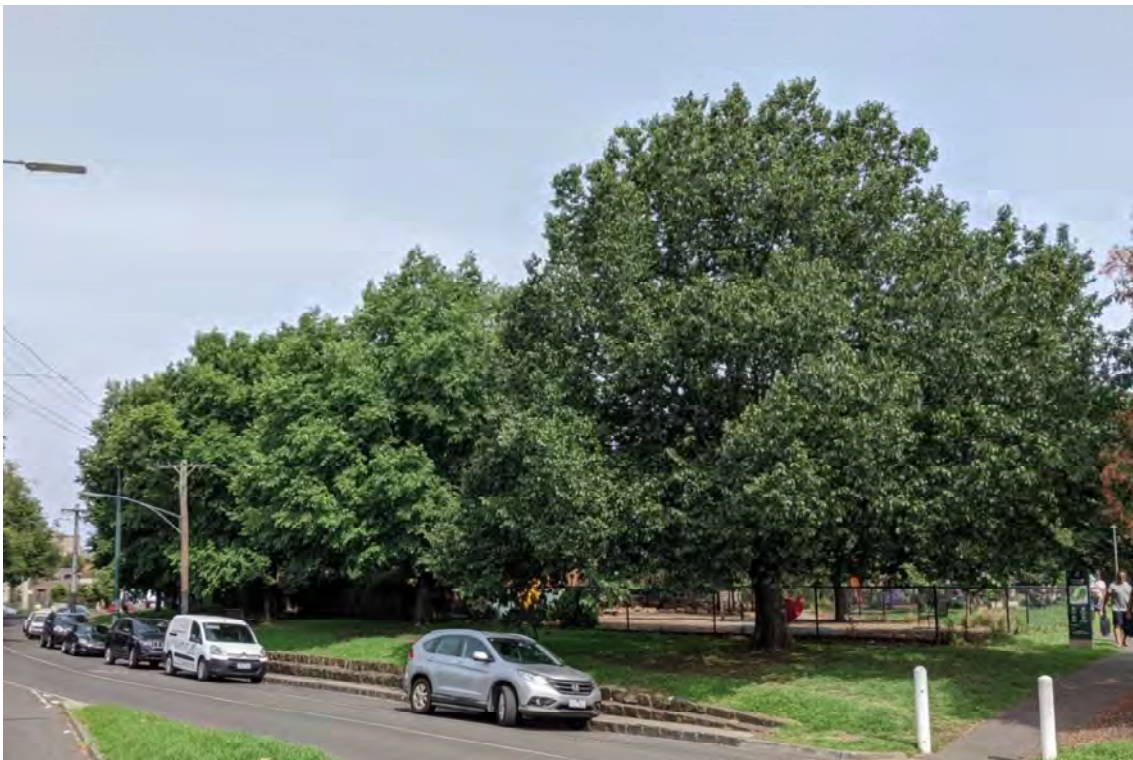
Figure 120 Elm row to southern end of Alfred Crescent, adjacent to south playground

A short row of Dutch Elm (*Ulmus x hollandica*) was established on the southern part of the gardens boundary to Alfred Crescent in the c. 1990s, between Grant Street and Jameson Street (Figure 120).

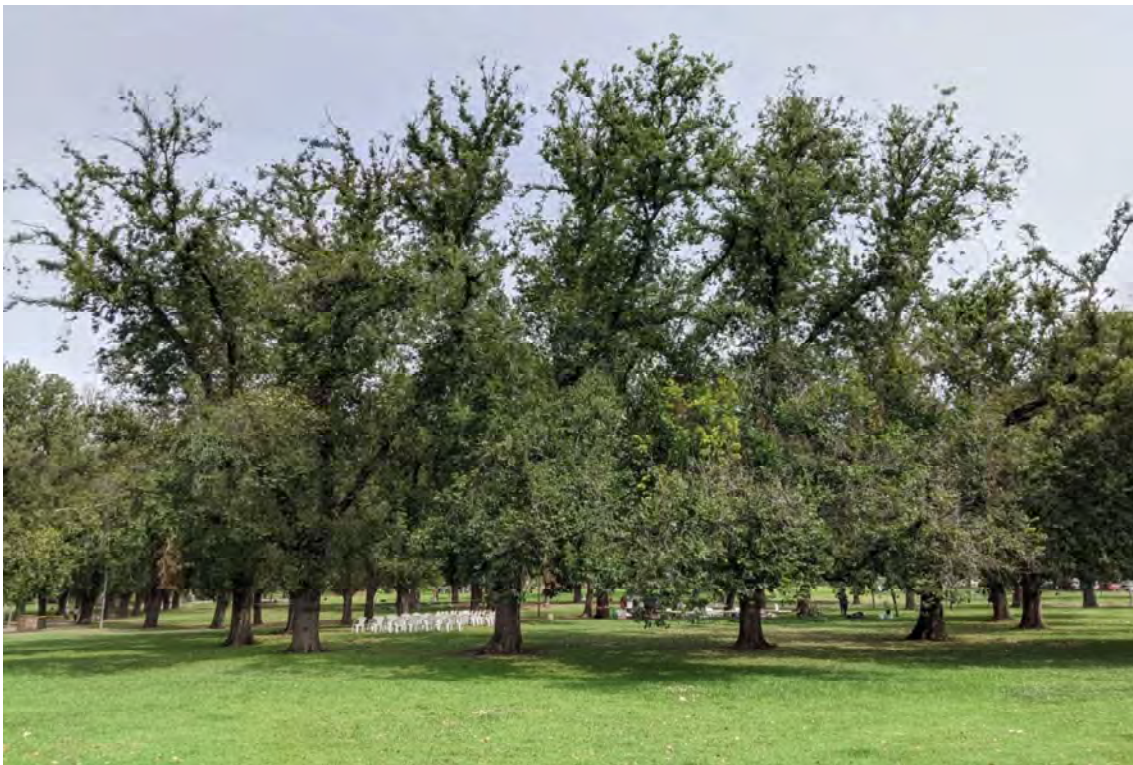
Figure 121 Circle planting of 13 Dutch Elms (*Ulmus x hollandica*) in the north-east of the gardens.

A circle of 13 Dutch Elm trees (*Ulmus x hollandica*) is set in one of the lawn areas in the north east of the Gardens (Figure 121). All but one of the trees are mature specimens. The thirteenth is a recent replacement for a missing specimen to complete the circle.

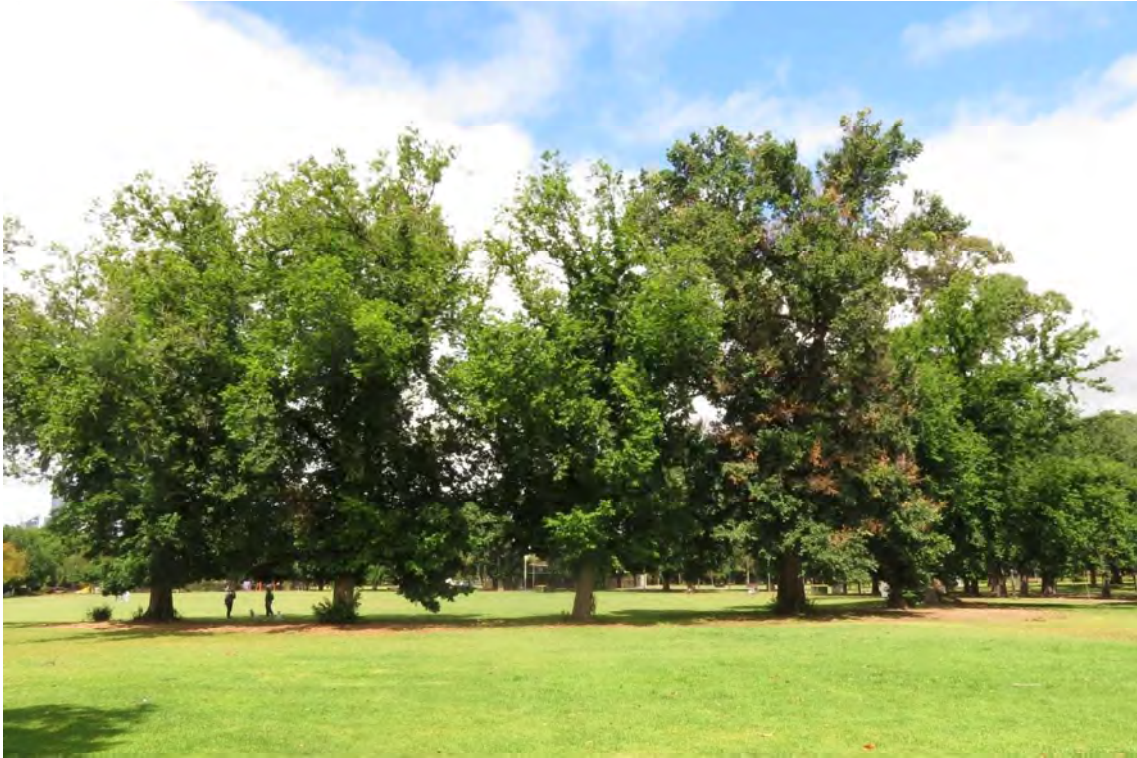
Figure 122 Dutch Elm arc (*Ulmus x hollandica*), formerly associated with a circular ornamental pond and now located at the north end of the Alfred Crescent oval

A semi-circle of seven mature Dutch Elms (*Ulmus x hollandica*) rings the northern end of the Alfred Crescent sports oval south of Rowe Street (Figure 122).
