### 3.2.3 W. T. Peterson Community Oval – Former Fitzroy Cricket Ground

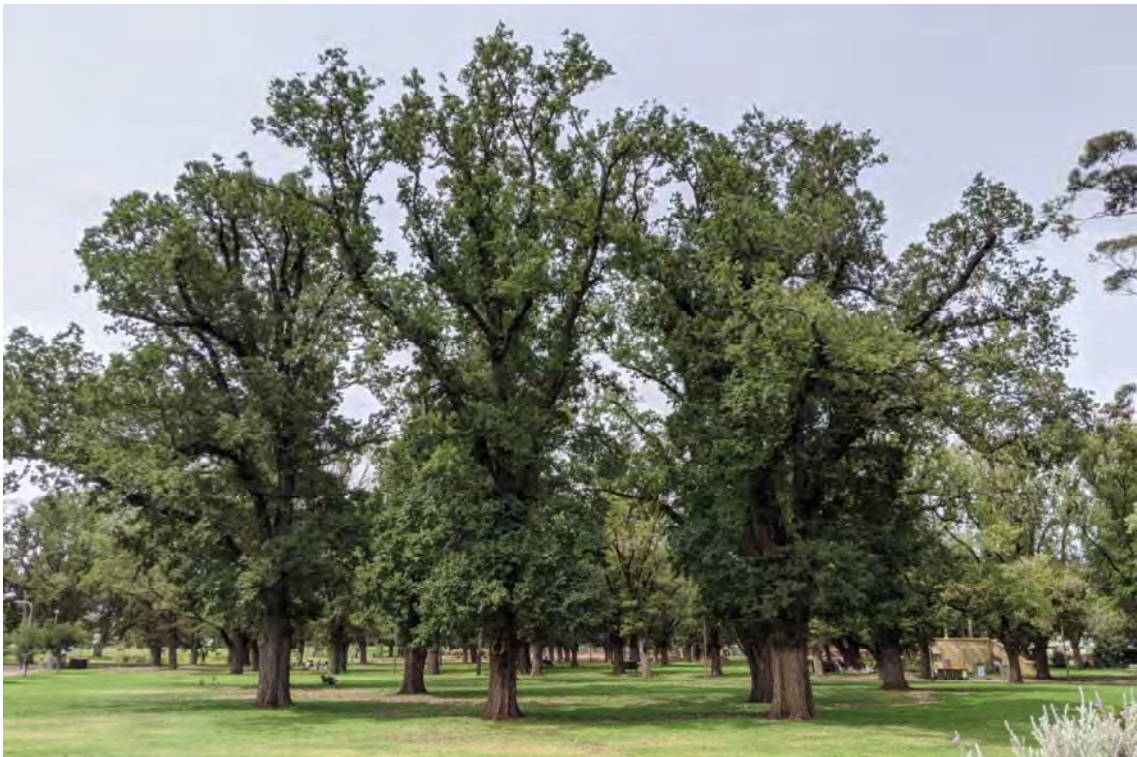
Figure 123 English Elm (*Ulmus procera*) circle with further trees to the interior, in the north-west of the Gardens.

A circle of nine English Elms (*Ulmus procera*) is present in the north-west of Edinburgh Gardens north of the Memorial Rotunda lawn. There are three gaps in the circle. Unlike the corresponding formation in the north-east section of the Gardens, this circle has three further Elms planted within the circle outline. All specimens are mature and are in good to fair condition.

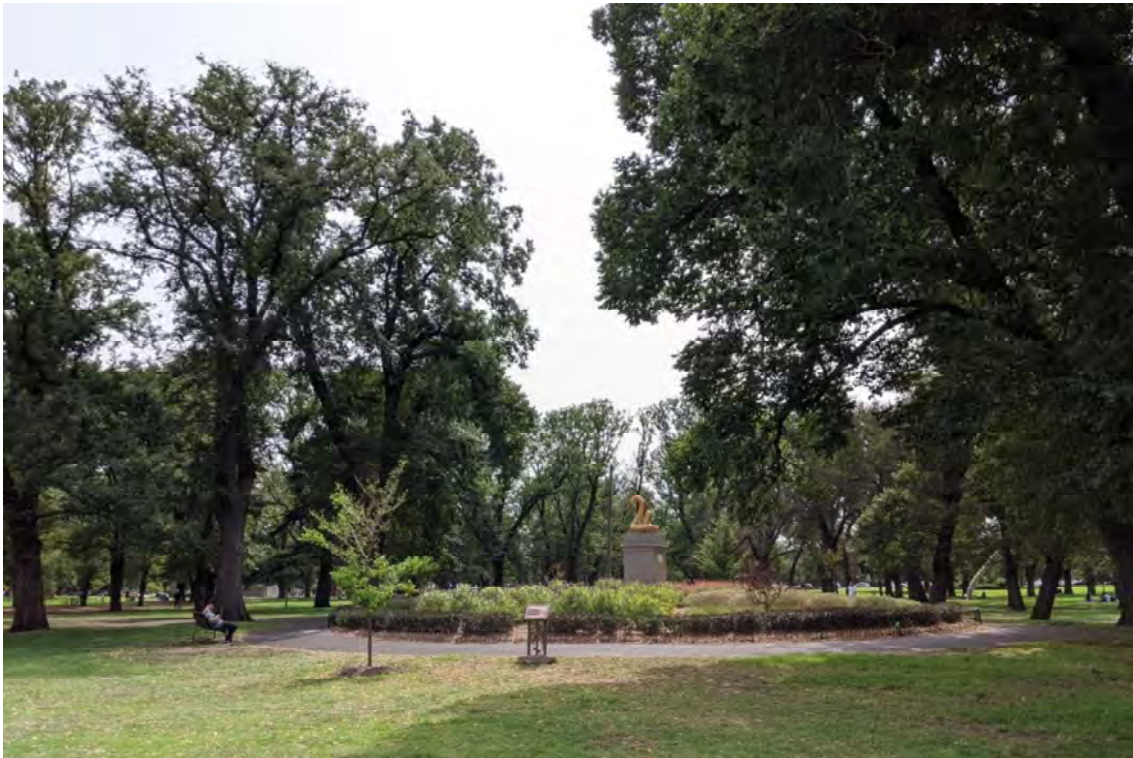
Figure 124 The Queen Victoria Plinth and garden is enclosed by a part circle and accompanying avenue of English Elm; a unplanted crossing path was subsequently removed and explains some of the 'missing trees' that would otherwise have formed a circular planting

Formerly enclosed by a circle of Elm trees at the intersection of two crossing paths, the Queen Victoria statue (refer section 3.10.5) stood in the midst of an elaborate garden. While the NW-SE crossing path was planted with Elms and remains today, the SW-NE crossing path does not appear to have ever been planted with trees, and was subsequently removed (c. 1970s).

It is likely that the circle had originally been fully enclosed by Elm trees; however by the time it was seen in aerial photographs from 1931 and 1945 it had suffered attrition and been reduced to a mostly complete south-east arc and a rump of an arc on the north-west.

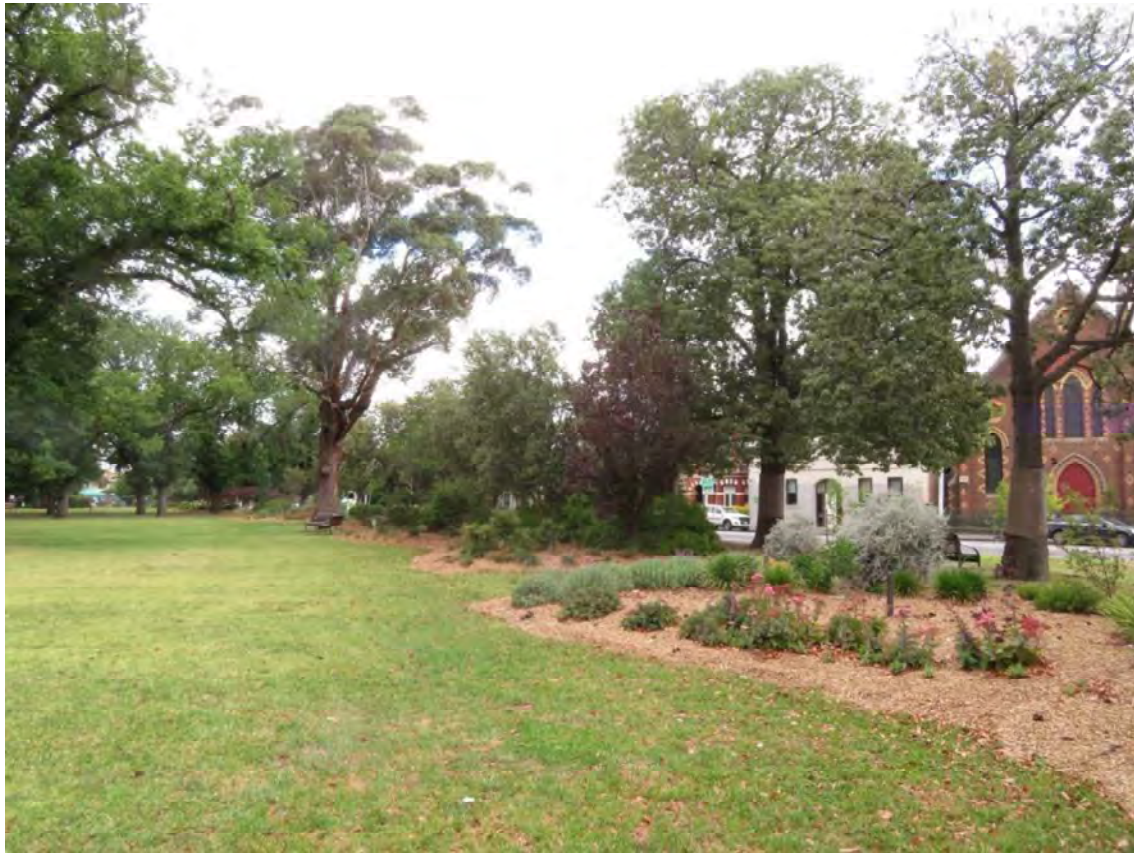
Figure 132 Ornamental planting beds to the boundary at Brunswick Street / St Georges Road; elements of the Kurrajong boundary row (early 1900s) and a specimen of Southern Mahogany Gum (possibly c. 1884) have been retained around the newly restored feature beds

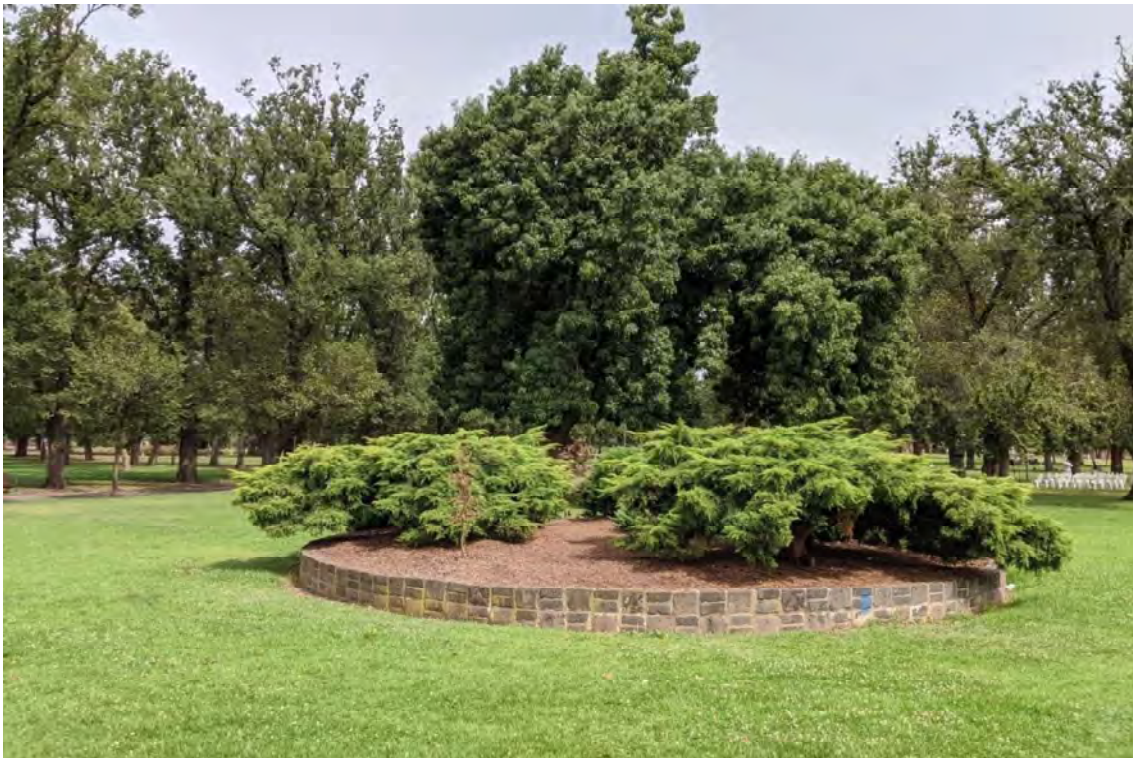
Figure 133 Bluestone circular planter

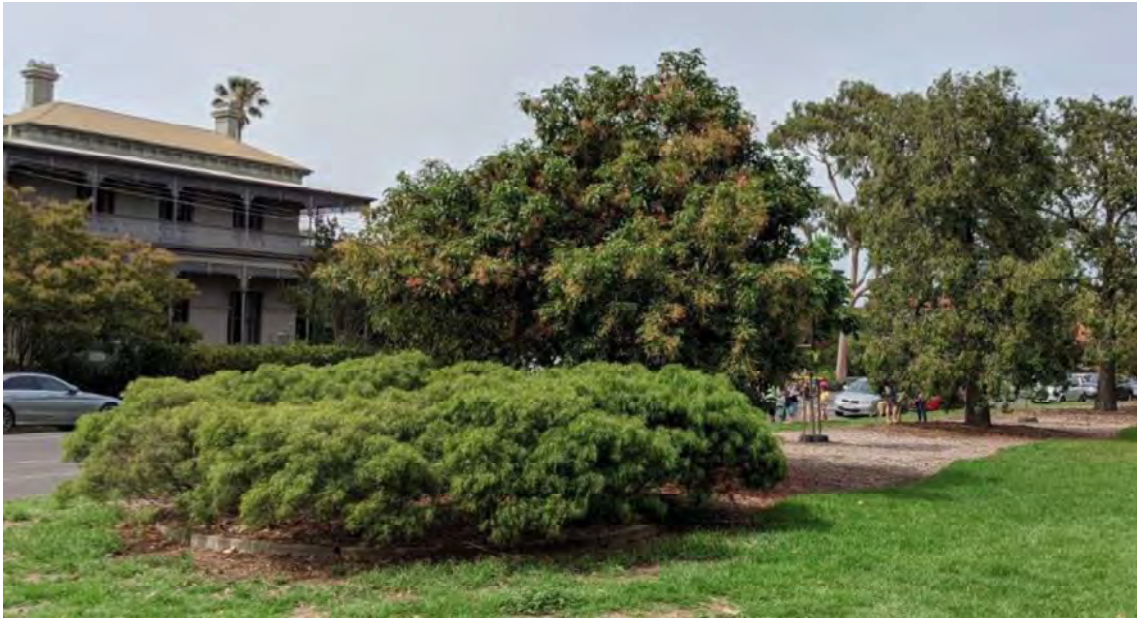
Figure 134 Rowe Street entrance beds

The Rowe Street entrance is flanked by a pair of circular beds defined by raised concrete kerbs (Figure 134). The beds date from c. 1950s-1960s, when they were constructed over a previous 'bar' form planting that defined the entrance in the 1940s. Plantings in these beds are refreshed periodically by the City of Yarra.
